MARINE INVESTIGATION REPORT

M04C0090

CAPSIZING

WORKBOAT 59E22354

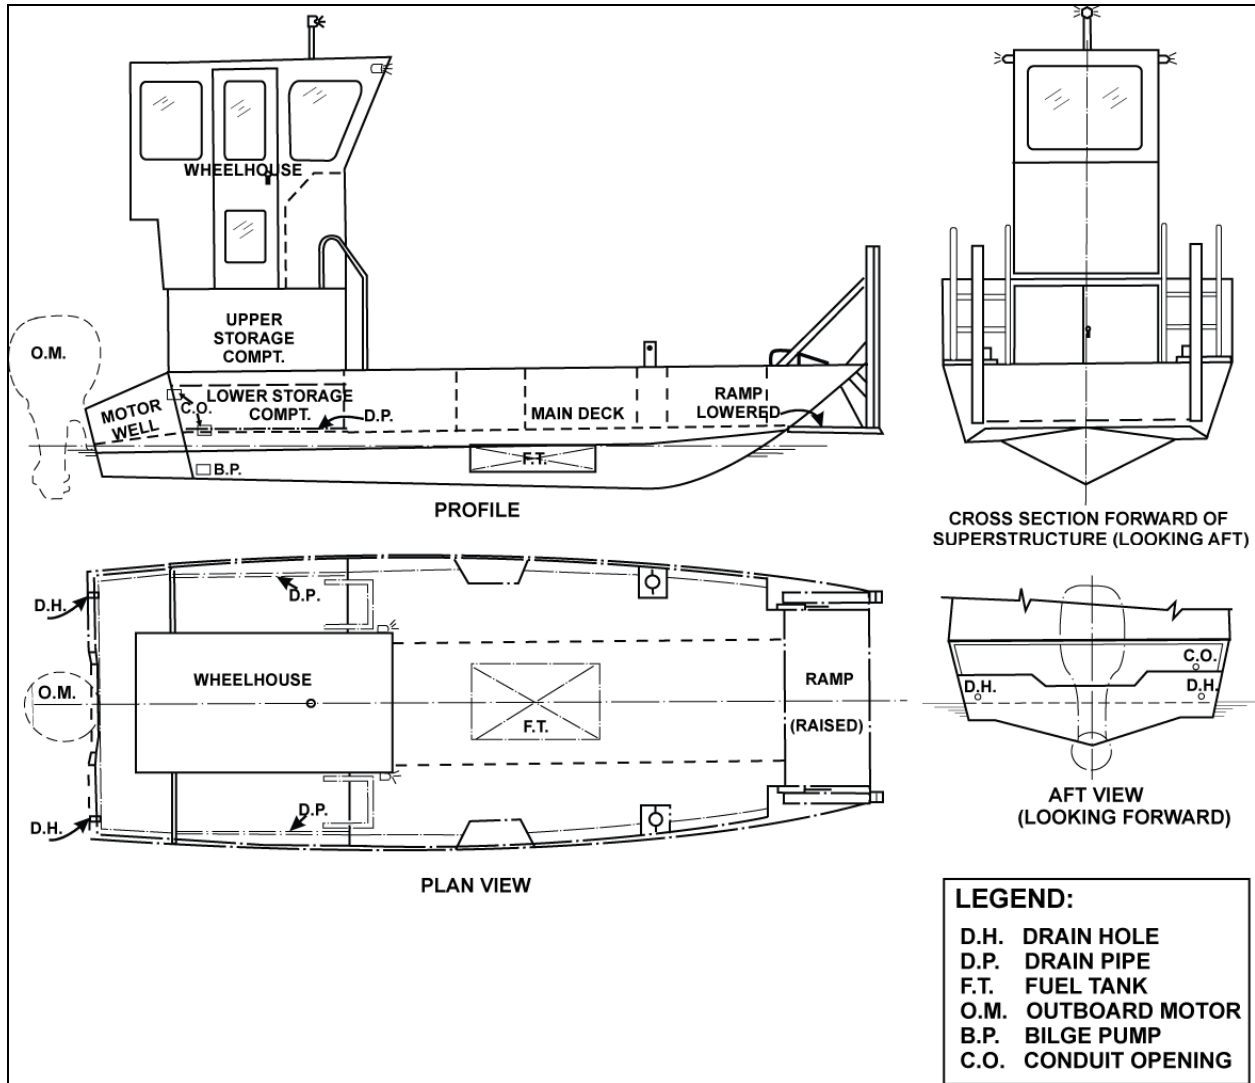
Figure 1. General arrangement

During construction, the following changes were made to the original design:

- the length was increased from 6.095 m to 6.81 m; and
- a four-stroke engine, weighing approximately 225 kg, replaced the two-stroke engine.
