**MARINE INVESTIGATION REPORT
M10C0043**

GROUNDING

**PASSENGER VESSEL *RIVER ROUGE*
QUARRY RAPIDS, RED RIVER
NORTH OF WINNIPEG, MANITOBA
29 JULY 2010**

Report Number M10C0043

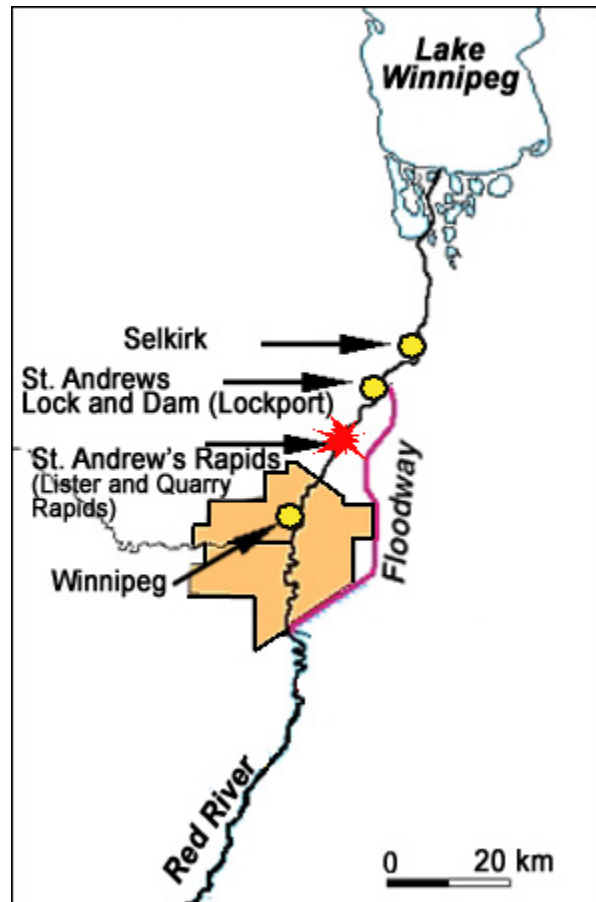
Figure 1. Occurrence location (see also Appendix A)

At approximately 1030, the *River Rouge* ran aground in the Quarry Rapids, about 2.5 kilometers downstream from Lister Rapids (see Appendix A) on a bottom of mud and rocks, approximately 45 m from the western shore. Upon grounding, the 1/O and the deckhand pushed the throttles ahead and the vessel advanced slightly before stopping. Ahead and astern engine movements to free the vessel were unsuccessful. The engineer examined the vessel and found no damage or ingress of water.
