MARINE INVESTIGATION REPORT

M11W0199

STRIKING OF BERTH

**ROLL-ON/ROLL-OFF FERRY *QUEEN OF COQUITLAM*
DEPARTURE BAY, NANAIMO, BRITISH COLUMBIA
18 NOVEMBER 2011**

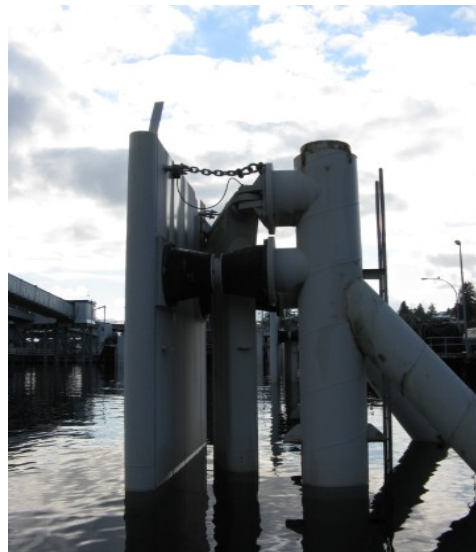
Photo 5. Undamaged starboard-side fender and articulated pad

The design of the fender and the articulated landing pad allows for a cushion effect during normal landings (Photo 5).

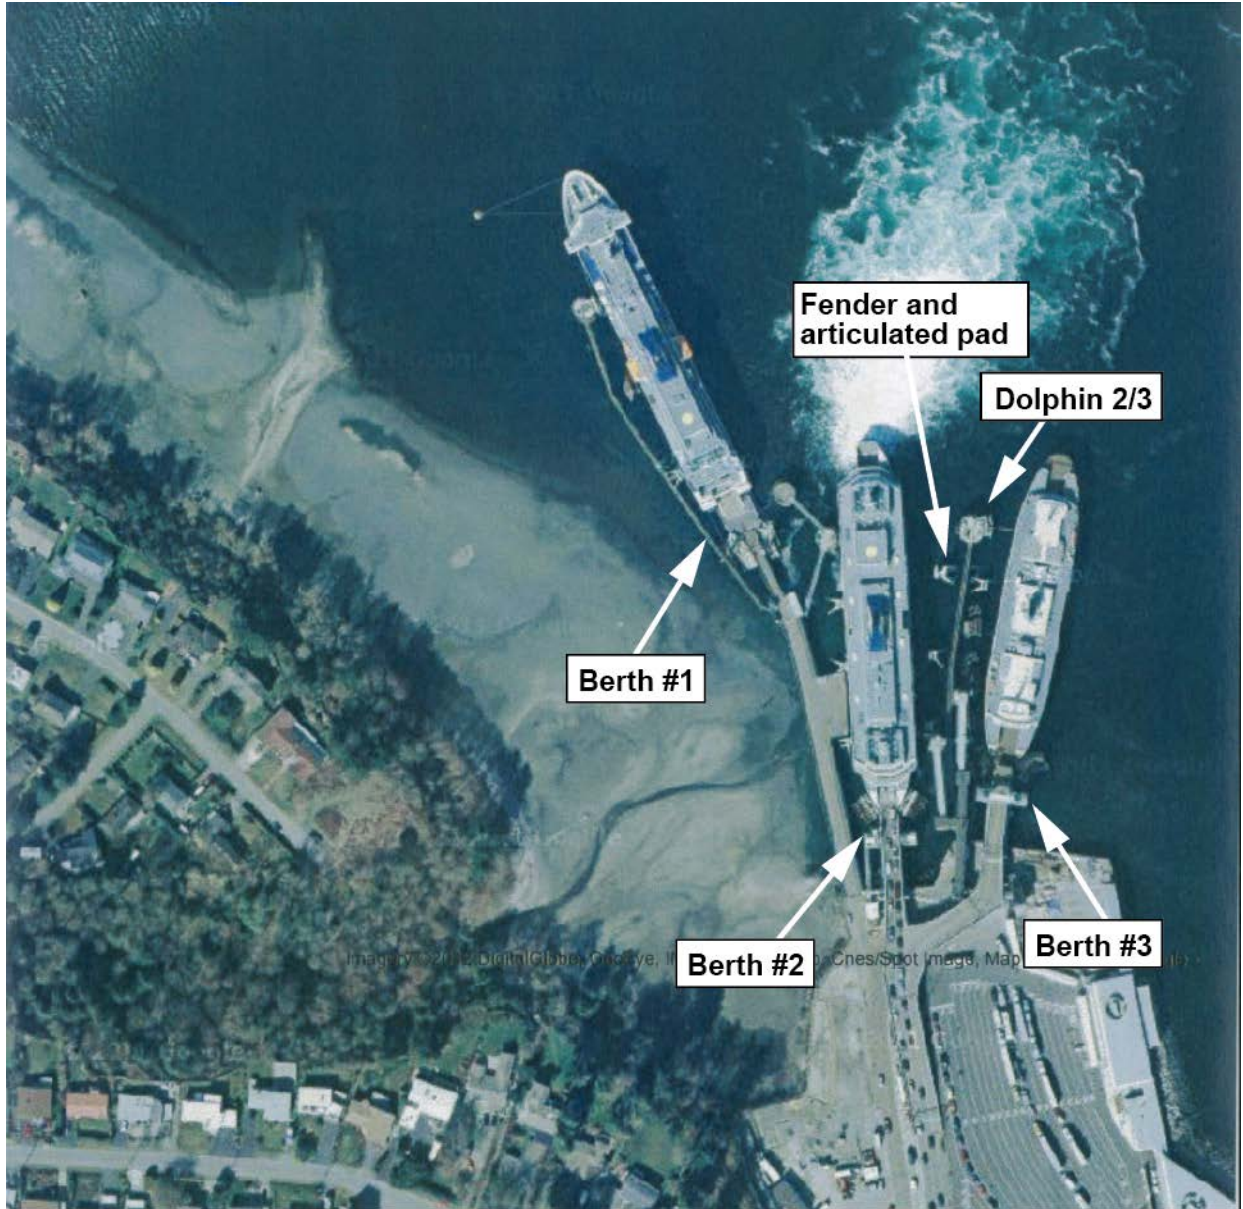
Appendix B – British Columbia Ferry Services Departure Bay Terminal

Damage to berth 2 (Appendix B) was limited to the port-side leads. This included damage to the outermost port-side fender and its articulated pad. As a result of the collision, the complete articulated landing pad broke free from the fender and ended up on the ocean floor. The attachment points between the fender and the articulated landing pad were torn away (Photo 4).
