**MARINE INVESTIGATION REPORT  
M14A0051**

**FLOODING AND SUBSEQUENT GROUNDING  
BULK CARRIER *JOHN I*  
OFF THE SOUTHWEST COAST OF  
NEWFOUNDLAND AND LABRADOR  
14 MARCH 2014**

14 March 2014

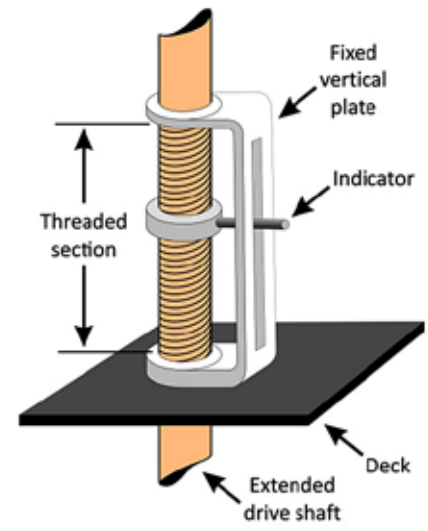
Figure 2. Diagram of a working gauge

Each valve position indicator consisted of a fixed vertical plate marked at the top, open, and at the bottom, closed. The plate had a vertical slot, within which an indicator affixed to threads on the valve extended drive shaft would move up or down indicating the position of the valve disc as the extended drive shaft was turned (Figure 2). The post-occurrence inspection found that the vertical plate of the valve position indicator located at the grating deck was bowed outwards and its indicator was bent upwards and therefore no longer fitted within the slot in the fixed vertical plate (Photo 5).
