**MARINE INVESTIGATION REPORT
M14C0106**

GROUNDING

**SELF-DISCHARGING BULK CARRIER ATLANTIC ERIE
PORT COLBORNE, ONTARIO
12 JUNE 2014**

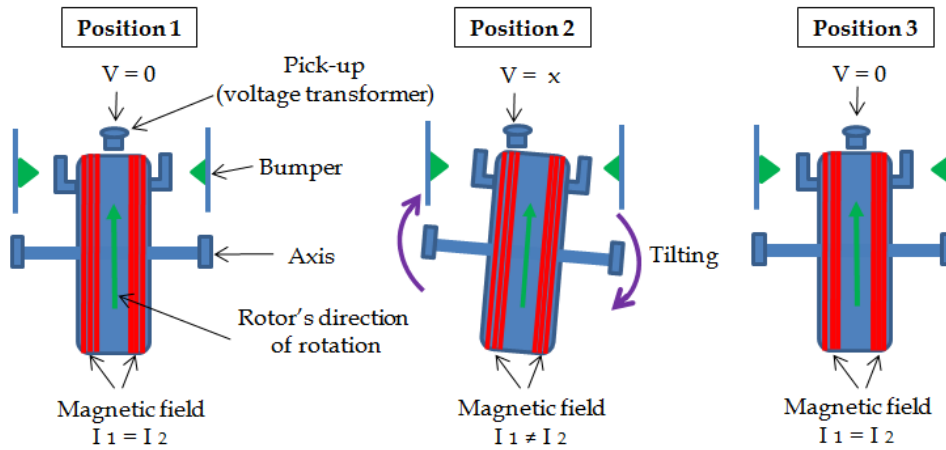
AT TIME OF OCCURRENCE

Position 2 = When a tilting effect is produced; the pick-up detects a differential in the magnetic field and induces correcting voltage.

Position 3 = The correcting voltage causes the rotor to return to its vertical position.

Position 4 = The rotor is in a vertical position, there is no magnetic field induced.
