**MARINE INVESTIGATION REPORT
M14P0023**

LOSS OF PROPULSION

TUG JOSE NARVAEZ
WITH BARGE TCT 8000
SOUTH ARM FRASER RIVER, BRITISH COLUMBIA
11 FEBRUARY 2014

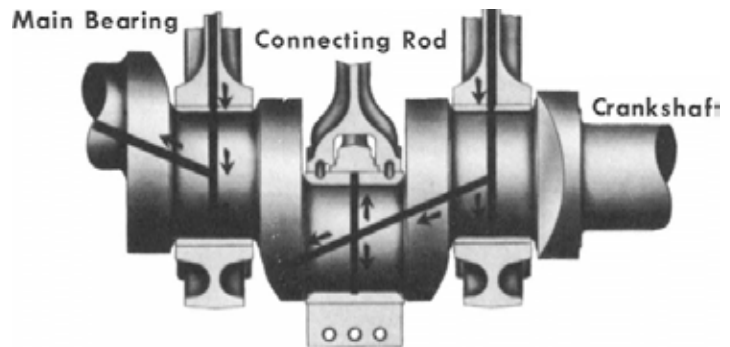
Figure 1. Crankshaft cross-section showing the paths taken by the lubricating oil when the bearing is lubricated (Source: Wajax Power Systems)

The lubrication system consists of engine-driven main lubricating and piston cooling pumps, an engine-driven scavenge pump, lube oil cooler¹⁵ where the lubricating oil is cooled by the cylinder fresh water, and an oil sump where excess oil in the system is collected (Appendix E). A pipe is located at each cylinder to direct a stream of oil through the piston carrier to the top of the piston. Drilled oil passages in the crankshaft conduct oil to the main bearings, connecting rod bearings, and other parts of the engine. The main engine system requires approximately 990 L of Society of Automotive Engineers (SAE) 40-grade oil.

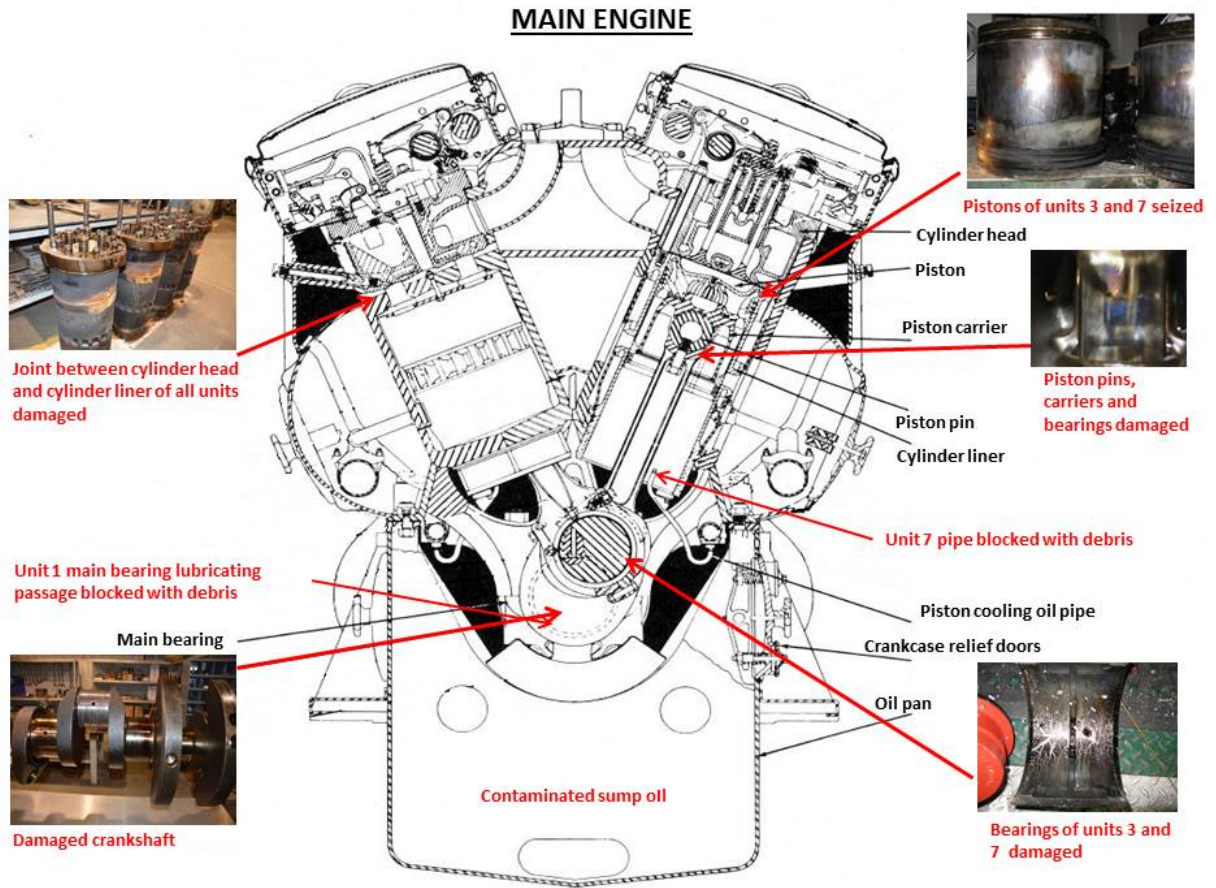
Appendix C – Cross-section of the main engine

The damage to the main engine was not immediately evident. When the engine was dismantled (Appendix C) post-occurrence by a workshop assigned by Lafarge, the following observations were made:
