MARINE INVESTIGATION REPORT M16P0162

Collision and sinking

*Tugs *Albern* and *C.T. Titan**

Northumberland Channel, British Columbia

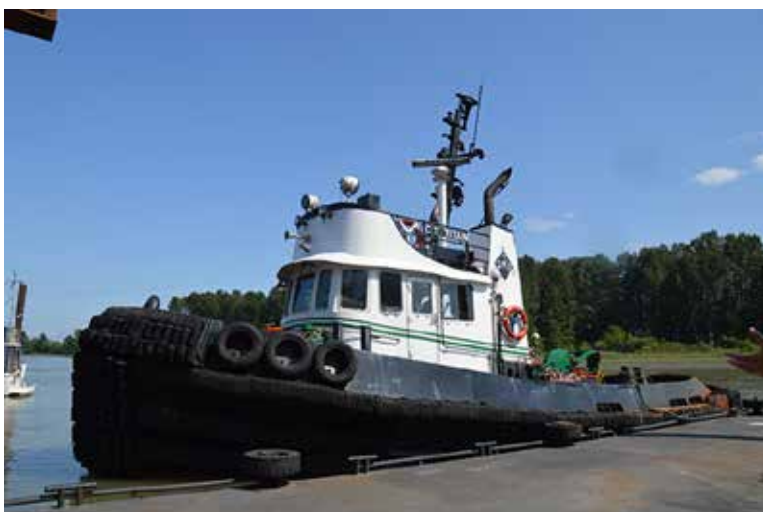
Figure 2. The tug *C.T. Titan*

The *C.T. Titan* is a twin-screw, steel-hulled, pointed bow tug with a rounded stern (Figure 2). The main deck forward of the wheelhouse has a bulwark, and the bow has fenders to protect it during operations such as pushing and log yarding.

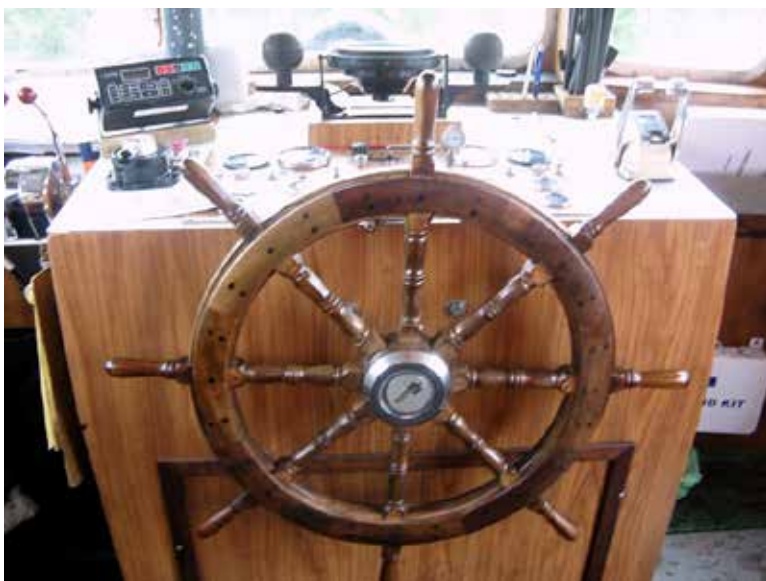
Figure 5. Wheelhouse control station on the *C.T. Titan*

The *C.T. Titan* has 3 identical propulsion control units, located in the wheelhouse (Figure 5), on the flying bridge, and near the towing winch. Each unit has a hand steering wheel and a jog, and 2 hand levers (Figure 6) that control the port and starboard main engines' revolutions and the propeller shafts' rotational direction individually.

On 25 May 2016, the TSB conducted tests on all 3 of the *C.T. Titan*'s propulsion control stations and observed no abnormalities with the propulsion control transfer system.

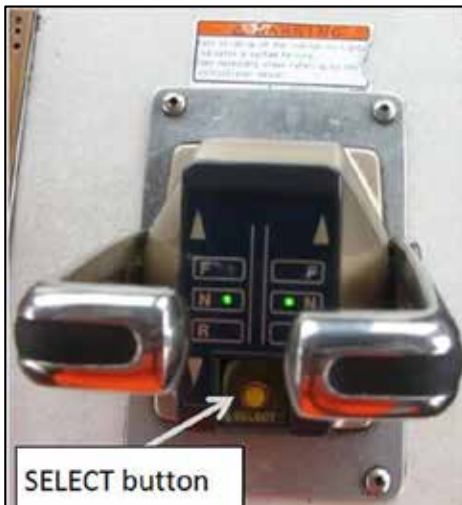
Figure 6. Hand levers on the *C.7. Titan's* propulsion control unit

Vessel propulsion can be controlled from only one station at a time.¹⁵ At the station where control is to be transferred, the operator sets the propulsion control levers to neutral (0°) and depresses the yellow SELECT button momentarily. The 2 green neutral (N) lamps illuminate continuously to indicate that the control transfer was successful (Figure 6).

To transfer propulsion control to another control station while the vessel is in gear, the operator goes to the other control station, sets the hand levers to neutral, and depresses the SELECT button. The 2 green neutral (N) lamps illuminate continuously to indicate that the control transfer was successful (Figure 6).

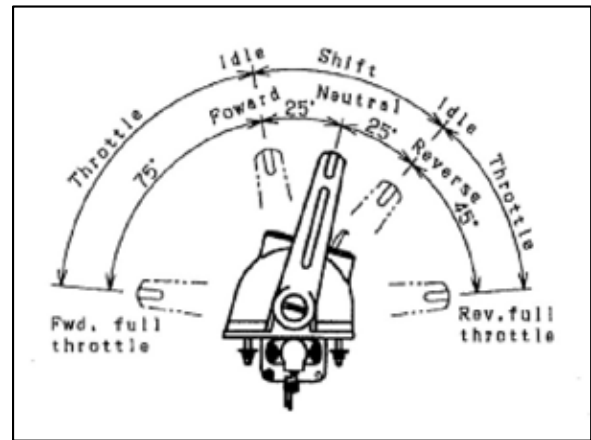
Figure 7. Side view of the propulsion control unit (Source: KE-4a Electronic Control System Instruction Manual)

When the hand levers are positioned between 0° and 25° in either forward or reverse, the vessel is in a neutral idling position (Figure 7). Notches at the 0° and 25° positions provide tactile feedback to help the operator locate these positions by touch when using the hand levers. Green lamps beside the neutral (N) indicator on the propulsion control unit light up when the propulsion control is successfully transferred to another propulsion control unit with the hand levers at the neutral position (0°). Moving the active control station hand levers beyond 25° in either forward or reverse will shift the engines to the corresponding throttle position, and the vessel will accelerate accordingly. Orange lamps beside the forward (F) and reverse (R) indicators on the propulsion control unit will illuminate to indicate that the vessel is in forward or reverse gear and is moving either ahead or astern.
