MARINE INVESTIGATION REPORT M17P0098

Partial sinking with loss of life

Commercial sport fishing vessel BC1329967
(*Catatonic*)

30 April 2017

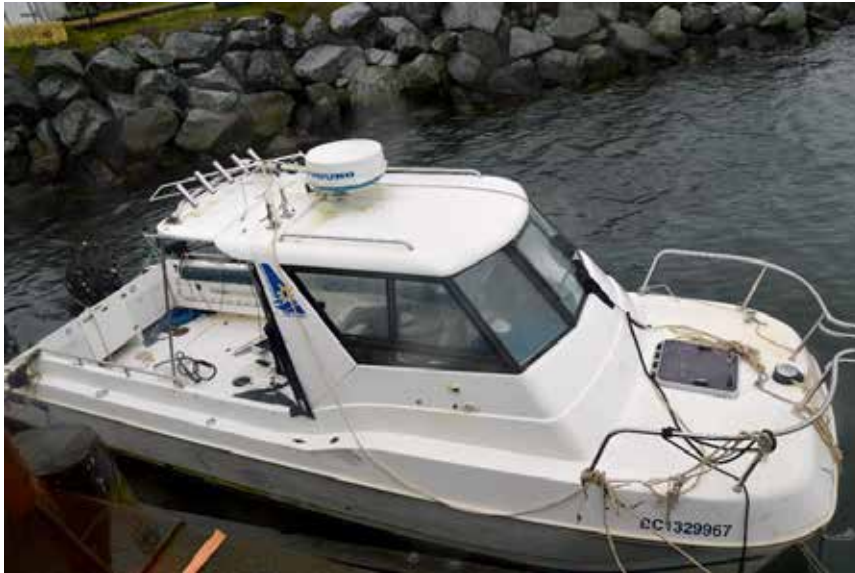
Figure 1. The Catatonic

The *Catatonic* is a twin-hulled catamaran made of fibreglass. The owner/operator purchased the vessel in January 2015 and used it for sport fishing activities (Figure 1).

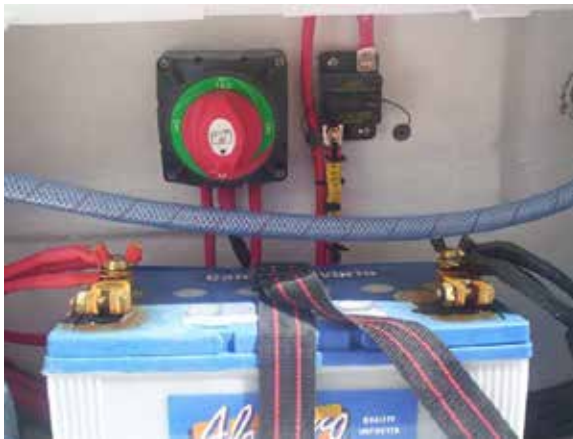
Figure 2. Builder-approved and standard battery bank arrangement in both battery compartments (Source: LeisureCAT Australia, LeisureCat 8000 Sportsfisher Owners Manual)

The *Catatonic's* original construction included 2 separate battery compartments. Each battery compartment contained an independent 12 V battery and a 4-way battery switch that could be set to Battery 1, Battery 2, Both, or Off (Figure 2). According to the owner's manual, to supply house power³⁰ or to start the engines, the operator had to set the 4-way battery switch to select the battery bank from which to draw power.³¹

As per the original design, the operator would select Battery 1 to power the port engine, and Battery 2 to power the starboard engine (Appendix F).³² The design provided a safety feature that ensured that the operator could not drain both batteries simultaneously and that there would always be a backup power source.
