Marine Transportation Safety Investigation Report M19A0090

CAPSIZING AND LOSS OF LIFE

Unregistered fishing vessel
Mackenna Point, Nova Scotia
08 April 2019

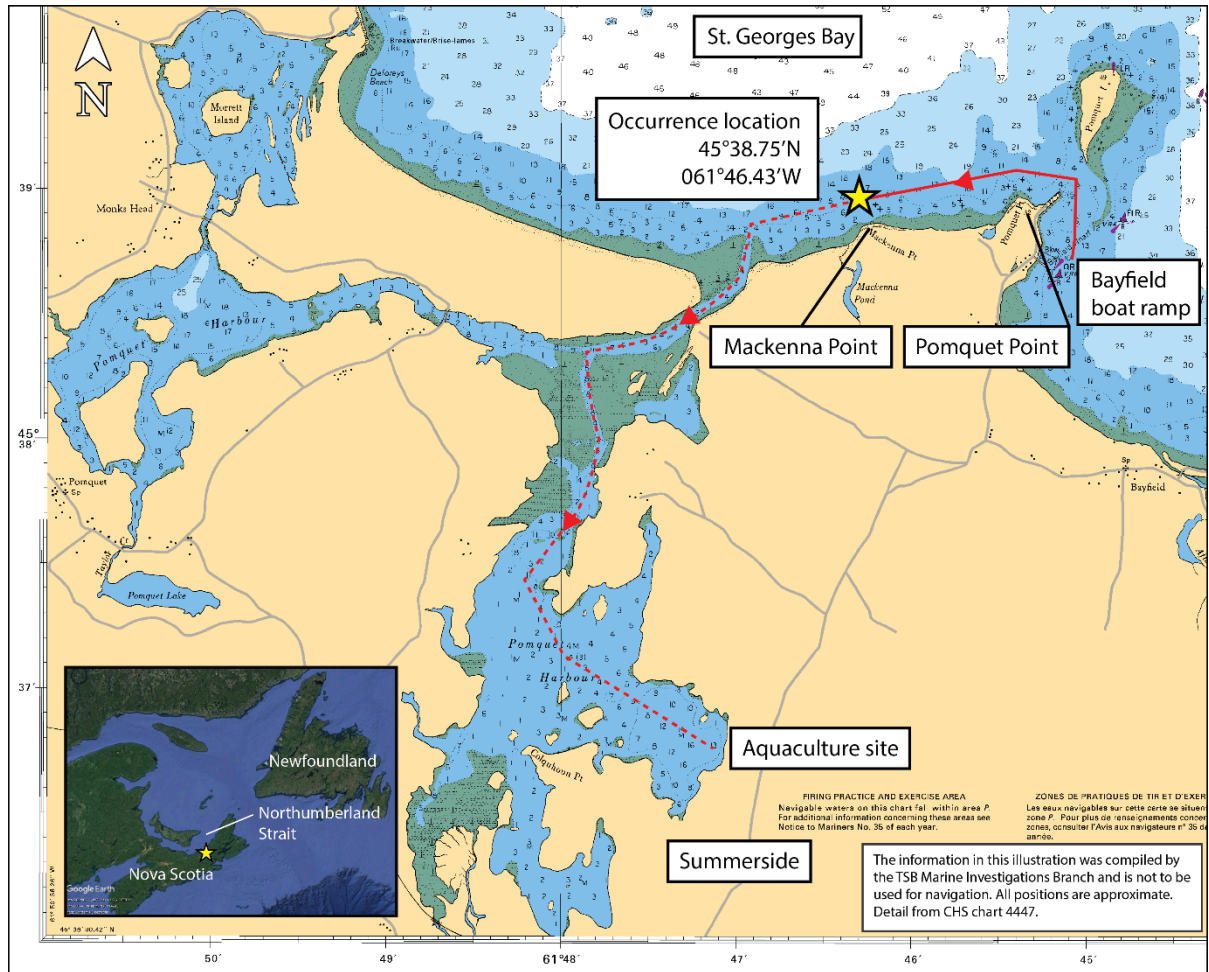
Figure 1. Area of the occurrence (Source: Canadian Hydrographic Service and Google Earth, with TSB annotations)

After the vessel completed $\frac{2}{3}$ of the exposed portion of the route, the water depth shallowed to 0.6 to 1.8 m and the wave height increased to about 1.25 m. The crew briefly discussed whether to continue the voyage or return to the departure point.

Since it was not much further to the Pomquet Harbour entrance and there was a risk of the vessel capsizing while turning around, the voyage continued. The vessel capsized at approximately 1425, about 50 m from the shore, near Mackenna Point, at 45°38.75'N, 061°46.43'W. No distress call was initiated.
