MARINE TRANSPORTATION SAFETY INVESTIGATION REPORT M20C0101

CREW FALL OVERBOARD AFTER WORKBOAT STRUCK BY MOORING LINE

Unregistered workboat belonging to the bulk carrier *Manitoulin*
St. Clair River, near Sombra, Ontario
12 May 2020

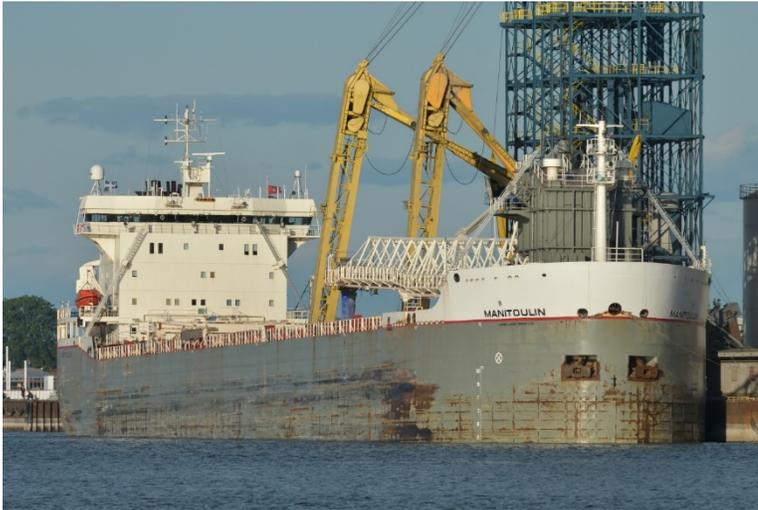
Figure 1. *Manitoulin* (Source: Martin Palardy)

The *Manitoulin* (Figure 1) is a River class self-unloading Great Lakes bulk carrier¹ of steel construction with the machinery space and accommodation located aft. The vessel has a self-unloading system with a boom that is located forward. On either side of the vessel, near amidships, there is a gangway that can be lowered to the waterline. The vessel has a rescue boat² located on the starboard side of the accommodation. The vessel also has a workboat that was stored on the main deck. At the time of the occurrence, the rescue boat was undergoing repairs and had been unserviceable since the morning of the occurrence.

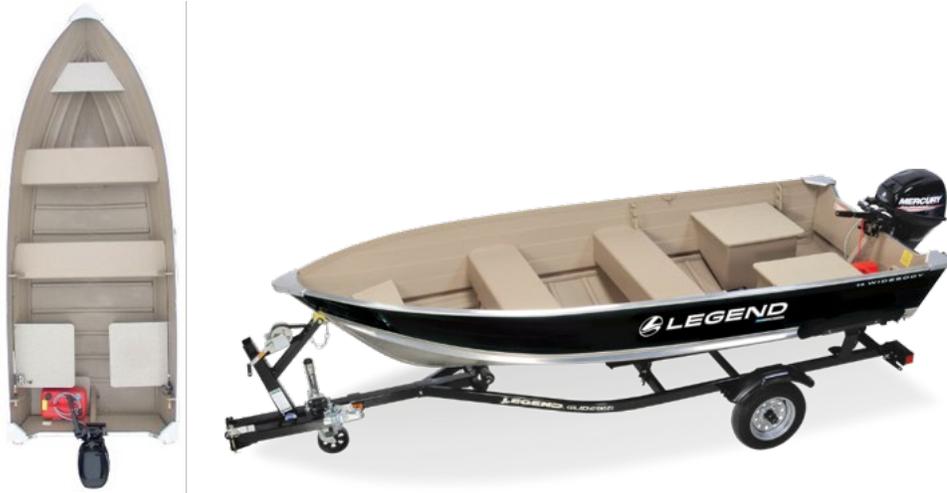
Figure 2. Overhead and profile views of a boat of the same model as the workboat on the *Manitoulin* (Source: Legend Boats)

The *Manitoulin's* workboat is a 14-foot aluminum boat of open construction (Figure 2). It has been on the *Manitoulin* since 2015 and is used approximately 15 to 20 times a year for crew transfers and mooring operations. At the time of the occurrence, the workboat was

powered by a 2-stroke 5 hp gasoline outboard engine that weighed 26.2 kg. The engine had a kill switch with a lanyard that was designed to be clipped to the workboat operator.

The workboat has a Canadian compliance notice³ posted on the hull that indicates the boat is a Category C, which is a designation for boats “designed to operate in typical steady winds of Beaufort force 6 or less and the associated significant waves heights of up to 2 m.”⁴ The compliance notice also indicates that the workboat’s recommended safe limits are as follows:

- A maximum of 4 persons on board, weighing a total of 275 kg
- A maximum total weight of 468 kg, including all persons, gear, and the engine
- An outboard engine with a maximum power of 26 kW and maximum weight of 190 kg
