MARINE TRANSPORTATION SAFETY INVESTIGATION REPORT M20P0229

SINKING WITH LOSS OF LIFE

Fishing vessel *Arctic Fox II*

11 August 2020

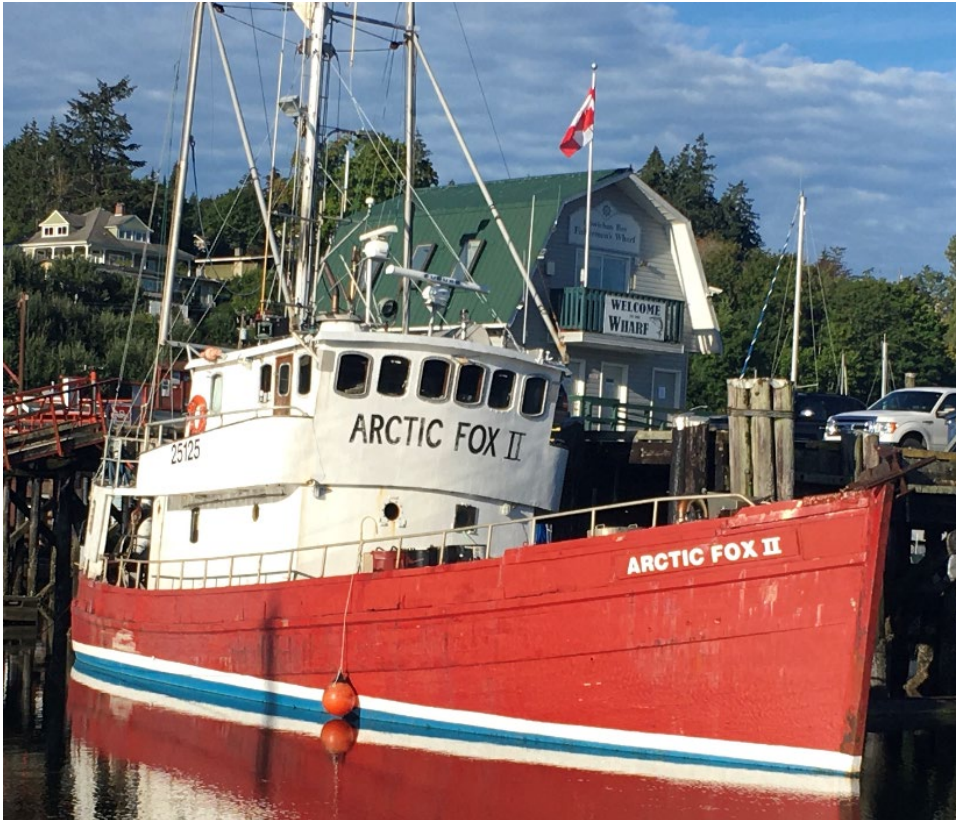
The *Arctic Fox II* (Figure 1) was a carvel-planked wooden vessel. The hull was a full displacement design that featured a nearly plumb bow, rounded bilges, a tapered stern, and steel hull stabilizers. The forward main deck had a forepeak access hatch and 3 fish-hold hatches. The aft main deck was partially covered and housed a centre-mounted fish-cleaning table, 2 hydraulic fishing-line haulers, and a ladder to access the upper deck. The upper portion of the deckhouse contained the bridge, the master's cabin, and an aft upper deck where the life raft was stored. The lower portion of the deckhouse contained 2 crew cabins, the galley, and a settee, and provided access to the engine room.

Figure 1. The Arctic Fox II, Cowichan Bay, 02 August 2020 (Source: Tibbie Adams)
