MARINE INVESTIGATION REPORT

M99W0078

STRIKING

TUG *SHEENA M* AND CHIP BARGE *RIVTOW 901*

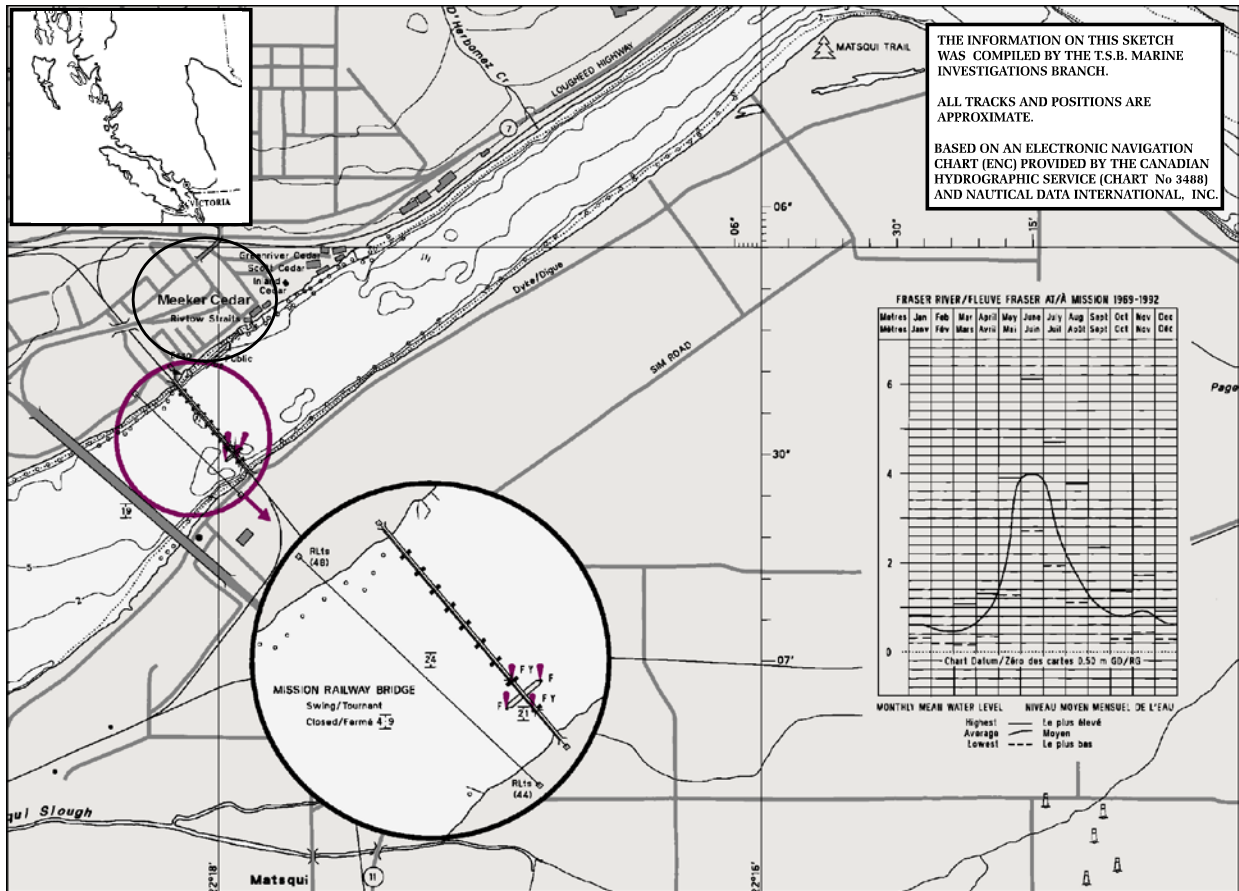
M arrived at the bridge at the given time and made the upstream passage through the south draw without event, arriving at the Meeker Cedar mill at approximately 2345 (see Figure 1).

The Meeker Cedar mill is situated on the north bank of the Fraser River approximately 500 m upstream of the CPR Mission Railway Bridge. Upon arrival at Mission the crew of the *Sheena M* secured the empty chip barge to a dolphin adjacent to the mill. They then took the chip barge *Rivtow 901*, loaded with approximately 2,100

Figure 1 of this report incorporates a section of the Canadian Hydrographic Service (CHS) chart (i.e., CHS 3488) for this section of the Fraser River. This chart indicates the CPR Mission Railway Bridge is supported by 10 piers when, in fact, the bridge has 13 supports. Since reconstruction the protection pier extends an additional 10 m upstream. The chart also indicates the bridge displays 2 white lights and 2 yellow lights. The bridge now displays 10 white lights and 4 red lights. The TSB has brought these changes to the attention of the CHS. Upon confirmation, they will issue a Notice to Mariners advising the marine community of these changes.
