# PIPELINE INVESTIGATION REPORT

## P17H0011

### **Third-party damage to a crude oil pipeline**

Enbridge Pipelines Inc.

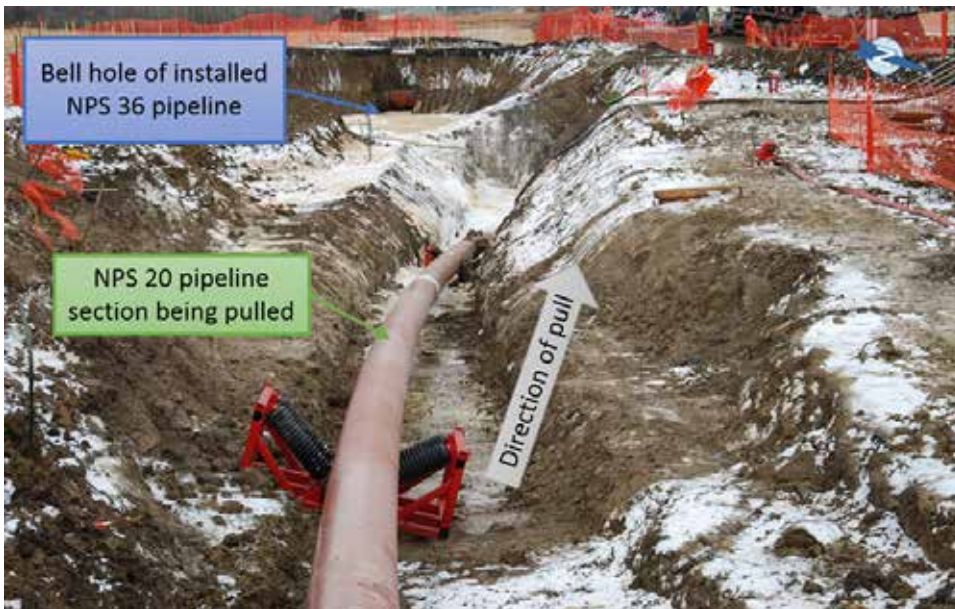
Figure 5. NPS 20 pipeline section at the entry point of the pull-through operation

At the east end of the corridor, there was a large excavation pit, known as a bell hole,<sup>10</sup> that was being used for the installation of the 2 GRP pipelines. The released product, approximately 1000 m<sup>3</sup> of petroleum crude oil condensate, was contained within the excavation pit (Figure 4). A section of the NPS 20 pipeline that was being pulled through was protruding from the entry point of the HDB operation (Figure 5).

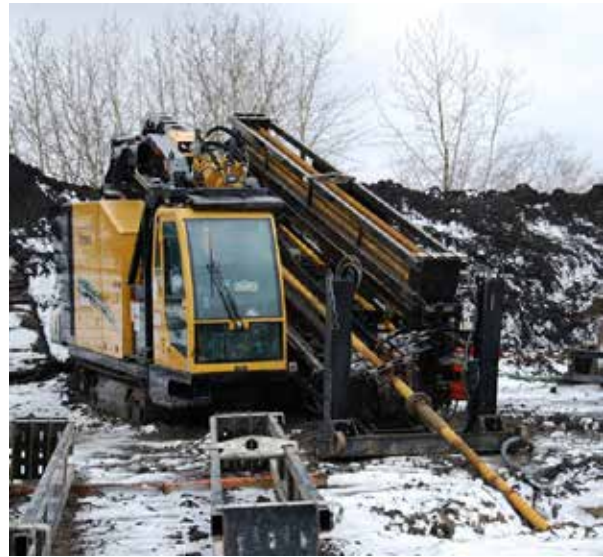
Figure 6. Drilling rig involved in the pull-through operation of the NPS 20 GRP pipeline

A drilling rig that was in the process of pulling the NPS 20 pipeline section was positioned at the west end of the western corridor (Figure 6).
