# PIPELINE INVESTIGATION REPORT

## P17H0019

### Crude oil leak

Enbridge Pipelines Inc.  
Edmonton North Terminal  
Sherwood Park, Alberta  
20 March 2017

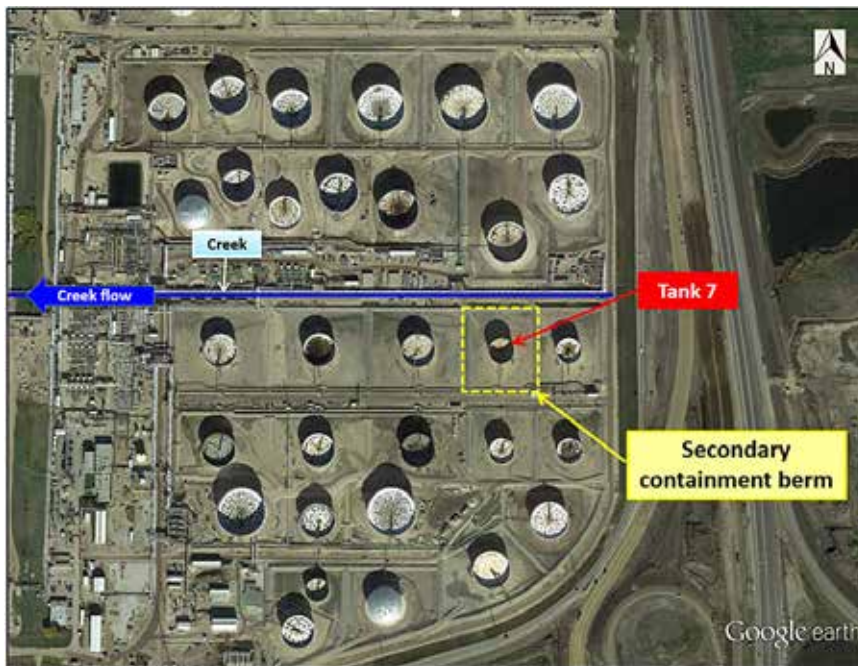
Figure 6. Tank 7 and its secondary containment berm (Source: Google Earth, with TSB annotations)

Tank 7 (the tank) is one of the crude oil storage tanks of the Enbridge's Edmonton North Terminal. It is located within a secondary containment berm adjacent to the south of the creek (Figure 6). The tank has a diameter of 33.5 m and is 14.6 m high, with a nominal capacity of approximately 12 700 m<sup>3</sup>.

The product that was contained within the Tank 7 berm was recovered by pumping, and then the contaminated granular soil covering the berm's surface was removed and replaced. The remediation of Tank 7's berm surface was completed by 11 April 2017.

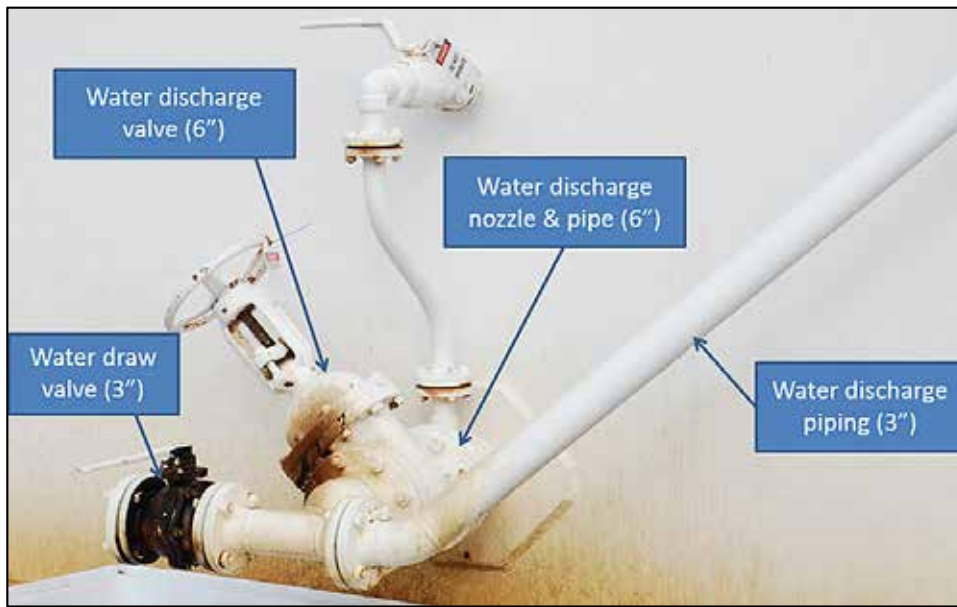
Figure 7. Main components of Tank 7's water draw system

At the time that the oily sheen in the creek was discovered, Tank 7 was in operation (i.e., product was flowing in and out of the tank), the 4 valves of the water draw system were in their normal positions, there was 9172 m<sup>3</sup> of product (synthetic crude oil) in the tank, and the pressure at the 3-inch water draw ball valve was approximately 83 kilopascals (12 psi).

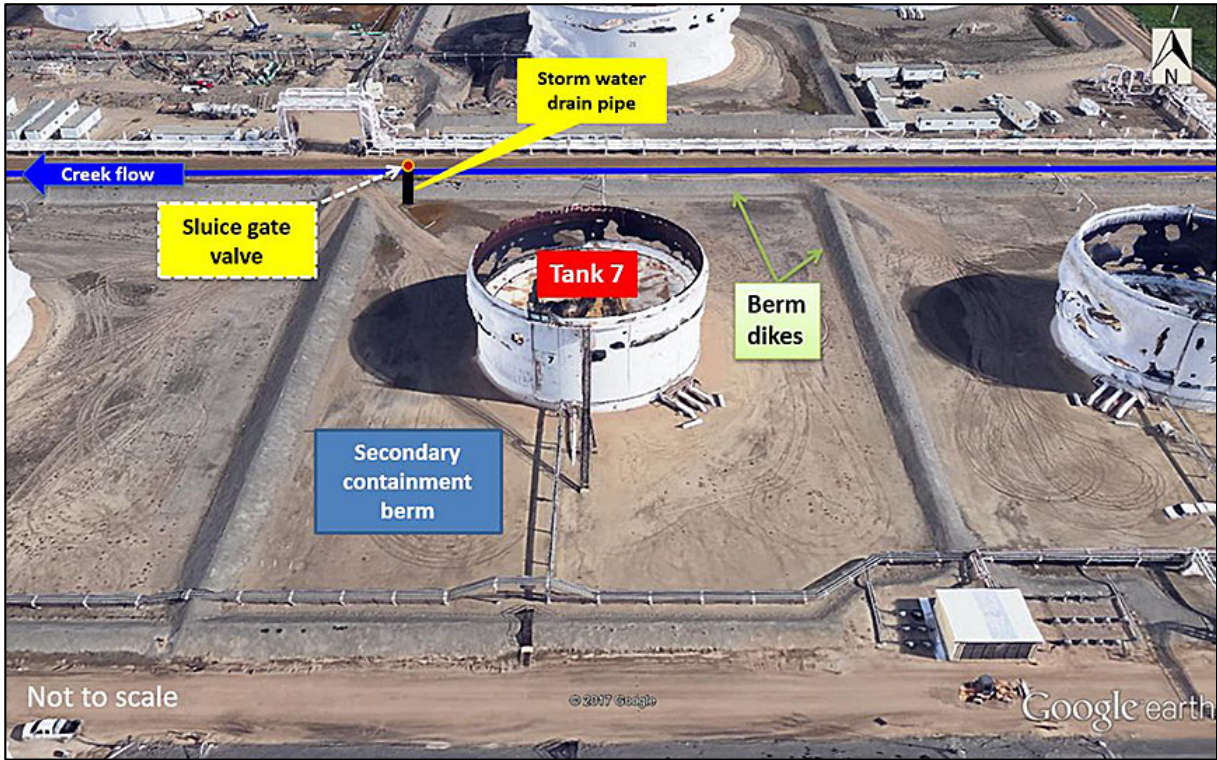
Figure 8. Storm water drain pipe for Tank 7 (Source: Google Earth, with TSB annotations)

The berm's water drainage system (i.e., the drain pipe and the sluice gate valve) is an integral part of the secondary containment system. As per regulatory requirements, the drainage system must be suitable for the expected working conditions and be maintained liquid tight.<sup>11</sup>

Surface and storm water collected within Tank 7's berm is manually discharged as required into the creek by way of a storm water drain pipe located at the northwest corner of the tank lot (Figure 8). The drain pipe is approximately 15 m long and 8 inches in diameter. It slopes approximately 4 degrees downward northward toward the creek. The drain pipe is equipped with a single sluice gate valve mounted on a flange and located at the pipe's outlet. This permits the berm's storm water drainage control to be accessible from outside the containment area, in compliance with regulatory requirements.<sup>12</sup> The drain pipe had likely been installed at the time of the berm's original construction.<sup>13</sup> The sluice gate valve was installed in 2012.

During storm water discharge operations, the operating condition or the performance of the berm’s drainage system is not specifically inspected. Enbridge procedures pertaining to storm water discharge operations do not require such an inspection.
