PIPELINE TRANSPORTATION SAFETY INVESTIGATION REPORT P22H0023

PIPELINE RUPTURE AND FIRE

NOVA Gas Transmission Ltd.
8-inch Simonette Lateral natural gas pipeline
Near Fox Creek, Alberta
07 April 2022

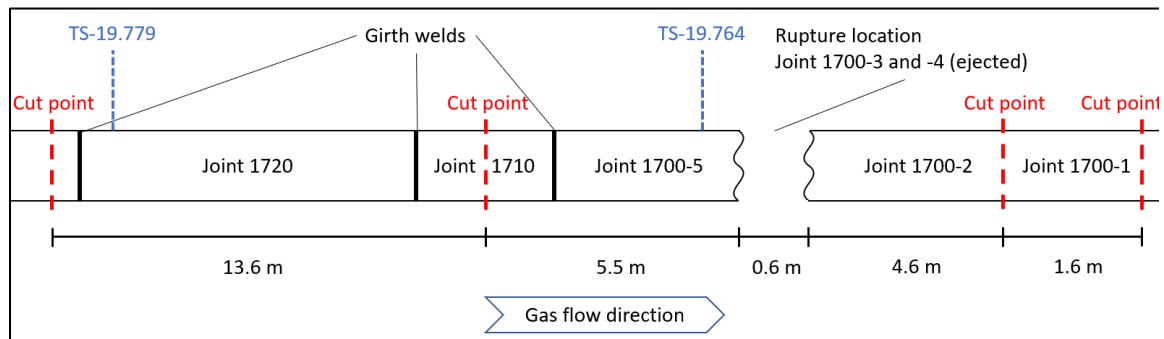
Figure 7. Pipe material collected for laboratory analysis (Source: TSB)

Approximately 25 m of pipe material recovered from the occurrence area was transported to the Acuren Group Inc. (Acuren) laboratory in Edmonton, Alberta, for analysis. The pipe material included parts of pipe joints 1700, 1710, and 1720 (Figure 7). The recovered CP system components from the TS-19.779 and TS-19.764 test stations were transported to the TSB Engineering Laboratory in Ottawa, Ontario, for analysis.
