RAILWAY INVESTIGATION REPORT
R05H0013

MAIN-TRACK DERAILMENT

CANADIAN NATIONAL
FREIGHT TRAIN U-78631-04
MILE 113.35, KINGSTON SUBDIVISION
PRESCOTT, ONTARIO
04 JULY 2005

Report Number R05H0013

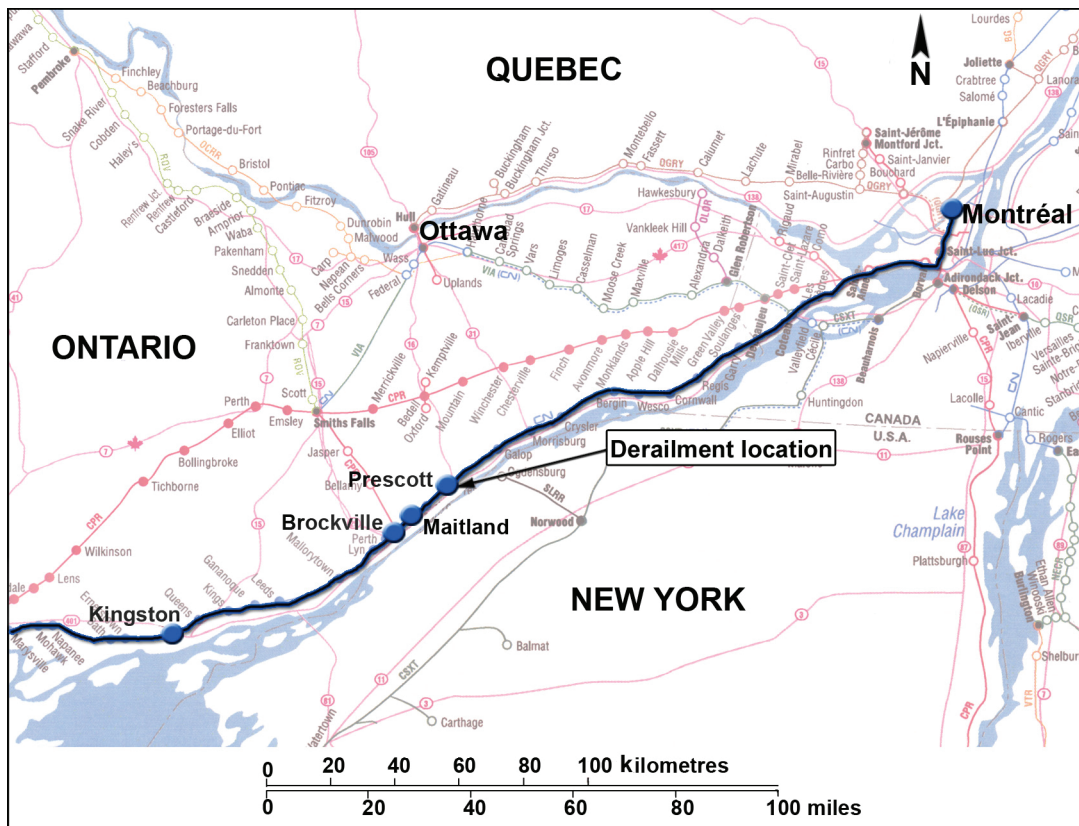
Figure 1. Derailment location

As the train approached Prescott, it was proceeding at 69 mph along the north main track with the throttle in position 8 and the brakes fully released. The crew observed a lateral deviation of the track at the east end of a turnout at Mile 113.36 and placed the throttle in idle. As the train was travelling over the lateral deviation, it experienced a train-initiated emergency brake application. The train came to rest at Mile 112.58 (see Figure 1). After initiating emergency procedures, the crew determined that all 51 cars had derailed, fouling the south main track.
