RAILWAY INVESTIGATION REPORT
R06D0044

PEDESTRIAN ACCIDENT

AGENCE MÉTROPOLITAINE DE TRANSPORT
COMMUTER TRAIN 928
MILE 13.40, DEUX-MONTAGNES SUBDIVISION
ROXBORO-PIERREFONDS, QUEBEC
22 NOVEMBER 2006

Report Number R06D0044

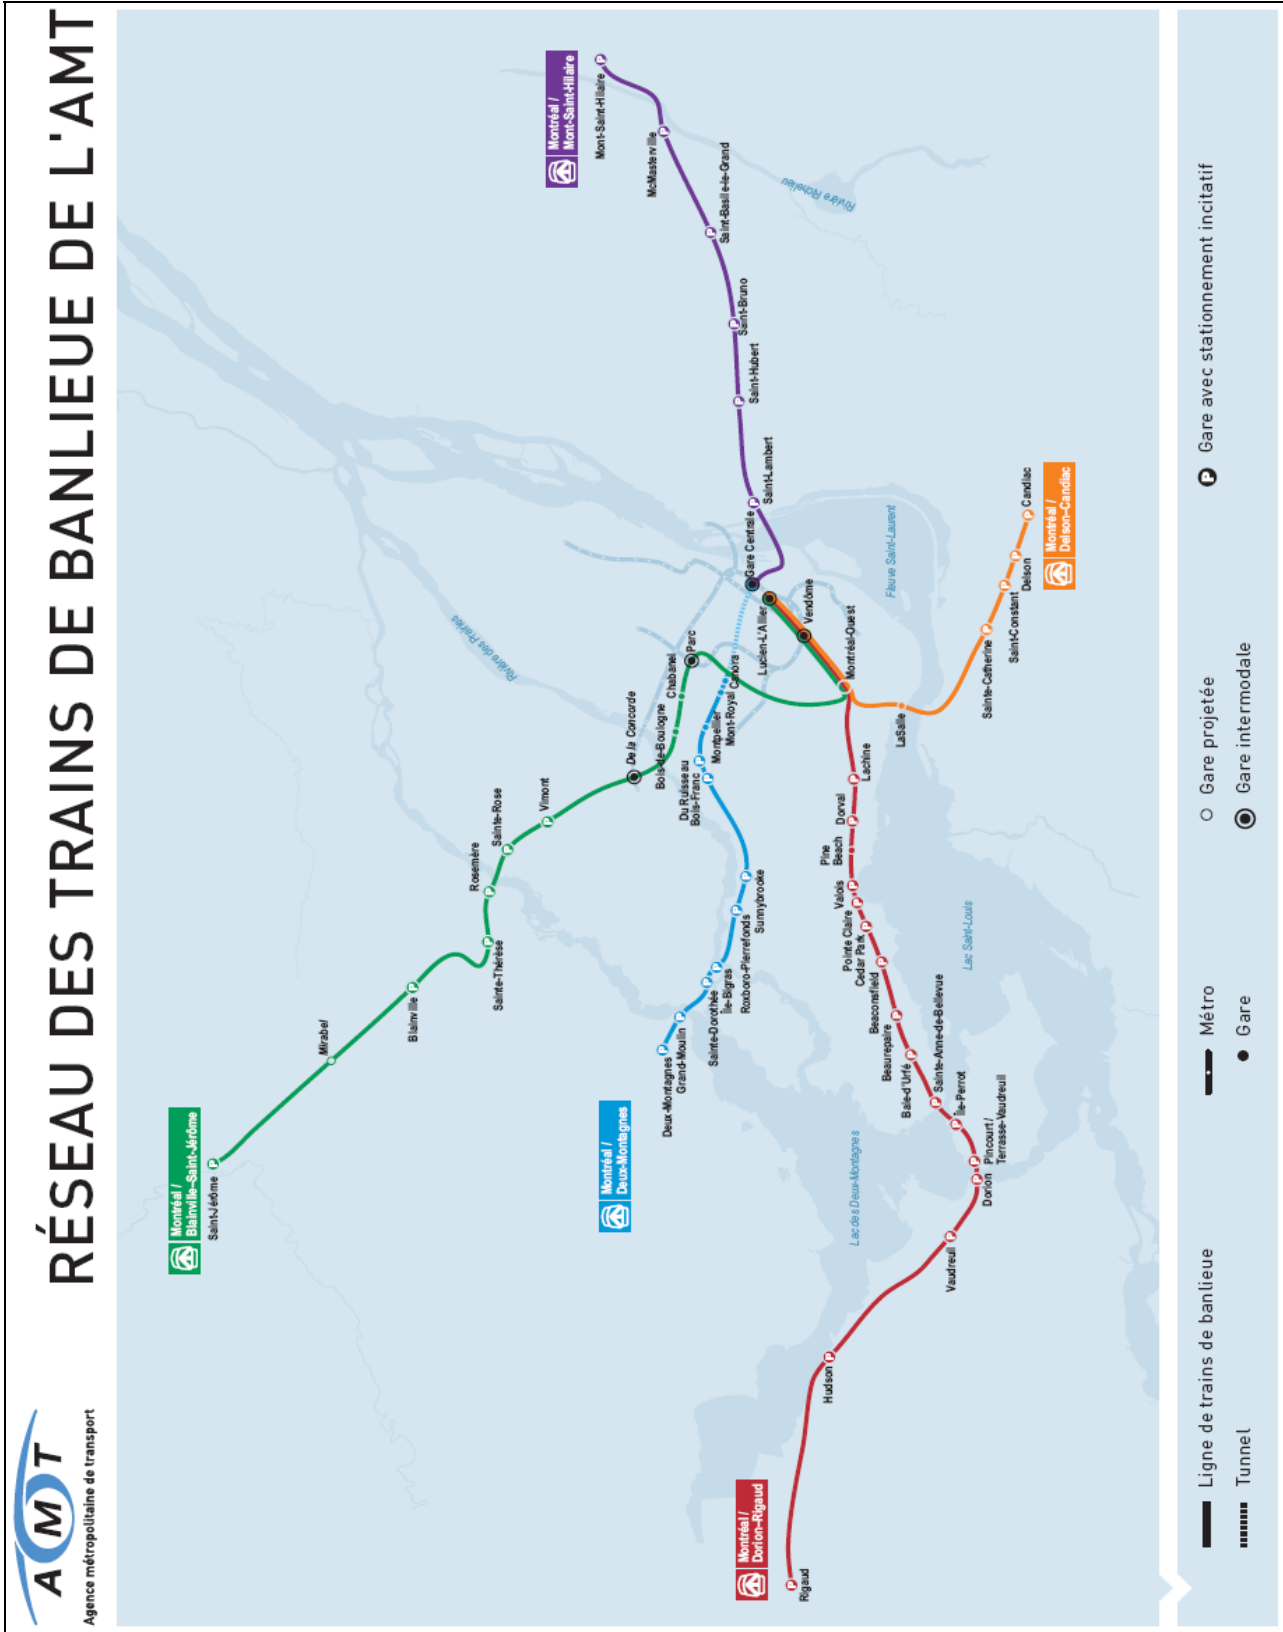
The AMT commuter train network consists of 5 lines, which include 49 operational stations, 38 of which have more than one track (see Figure 1). Twenty-eight of these multi-track stations have tunnels or pedestrian bridges that give commuters access to the platforms without having to cross the tracks; the other 10 have platform links with no system to indicate that a train is approaching or to keep pedestrians off the tracks when a train is coming in.

Figure 1. Commuter train station location plan (This figure does not exist in English.)
