RAILWAY INVESTIGATION REPORT
R08V0270

NON-MAIN-TRACK TRAIN RUNAWAY AND COLLISION

KETTLE FALLS INTERNATIONAL RAILWAY
WANETA TURN ASSIGNMENT
MILE 141.20, KETTLE FALLS SUBDIVISION
WANETA, BRITISH COLUMBIA
29 DECEMBER 2008

Report Number R08V0270

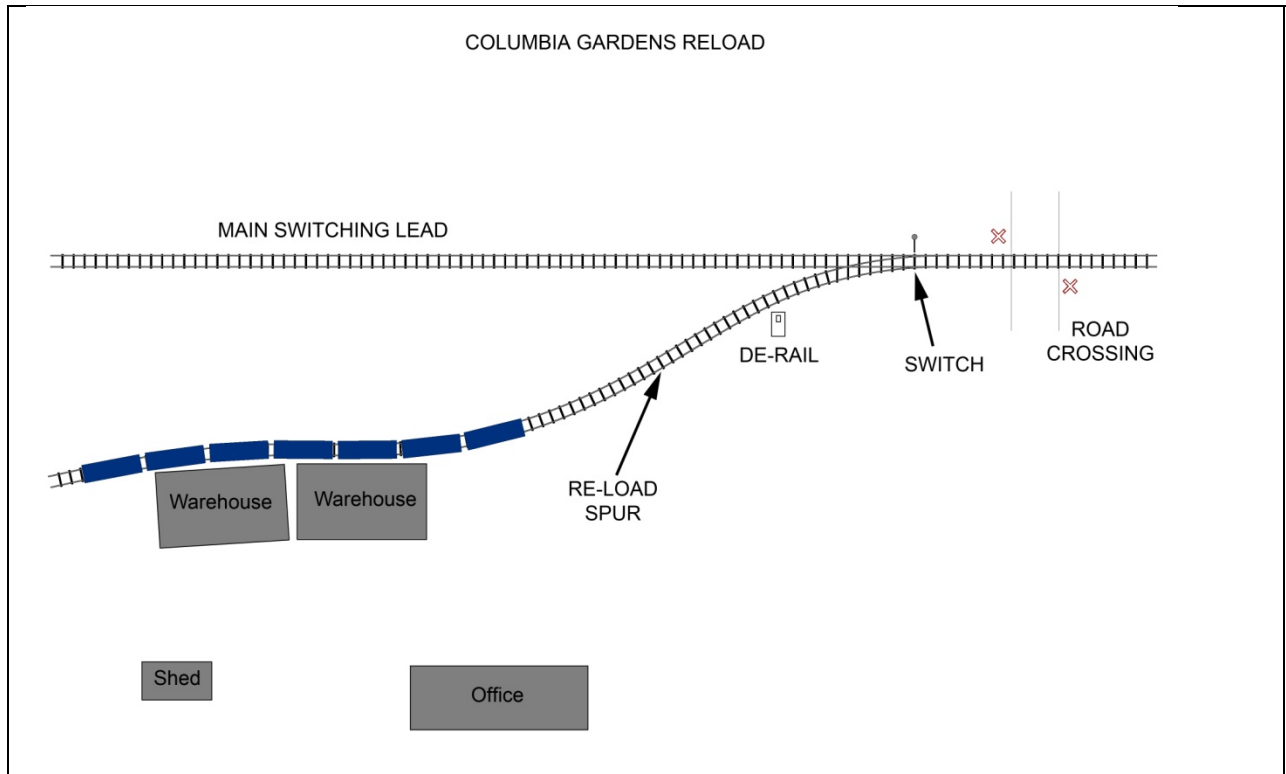
Figure 2. Columbia Gardens Reload

On the way to Columbia Gardens, switching was performed at Quirk Spur (Mile 142.7), where one loaded car of ammonium sulphate fertilizer was added to the train. The assignment arrived at Columbia Gardens with two locomotives, one covered hopper car loaded with fertilizer, and four empty boxcars. The assignment then coupled onto seven loaded boxcars of wood pulp that were in the reload spur (see Figure 2). The conductor had driven ahead of the assignment by truck, removed the derail, and lined the switch to the spur. The trainman, who was riding on the point of the movement, detrained and positioned himself at the switch to facilitate the assignment placing the loaded wood pulp cars on the adjacent track, the main switching lead.
