**RAILWAY INVESTIGATION REPORT
R09W0016**

**ROLLING STOCK DAMAGE WITHOUT
DERAILMENT OR COLLISION**

**CANADIAN NATIONAL
FREIGHT TRAIN NUMBER M-30451-11
MILE 238.30, REDDITT SUBDIVISION
DUGALD, MANITOBA
14 JANUARY 2009**

Report Number R09W0016

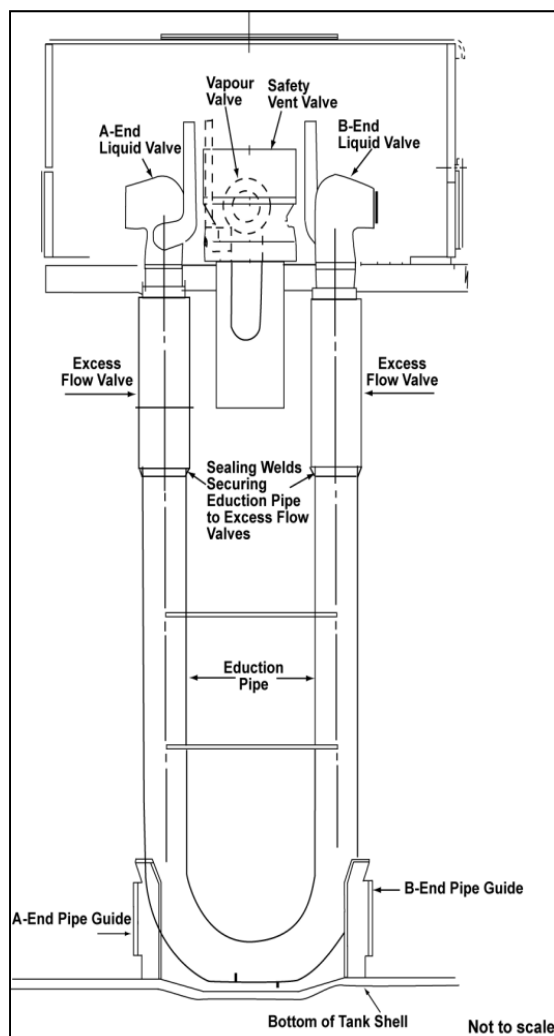
Figure 2. Eduction pipe arrangement

The manway assembly for this car included the manway and lid, 2 liquid valves, 1 vapour valve, 1 safety vent valve, a thermowell, a gauging device and the U-shaped eduction pipe. The eduction pipes fit into the bottom of the excess flow valves which in turn are welded to the bottom of the liquid valves. The eduction pipes are secured to the excess flow valve casings with 3/16-inch fillet welds (see Figure 2). The welds provide a seal and are not meant to be structural. The assembly is placed onto the car so that the liquid eduction pipe sits into two guides welded to the inside of the tank shell bottom. The guides prevent longitudinal pipe movement. The entire assembly is secured to the car by bolts on the top of the tank shell.
