**RAILWAY INVESTIGATION REPORT
R11D0099**

NON-MAIN-TRACK DERAILMENT

**AGENCE METROPOLITAINE DE TRANSPORT
COMMUTER TRAIN NO. 805
MILE 73.84, SAINT-HYACINTHE SUBDIVISION
MONTRÉAL, QUEBEC
09 DECEMBER 2011**

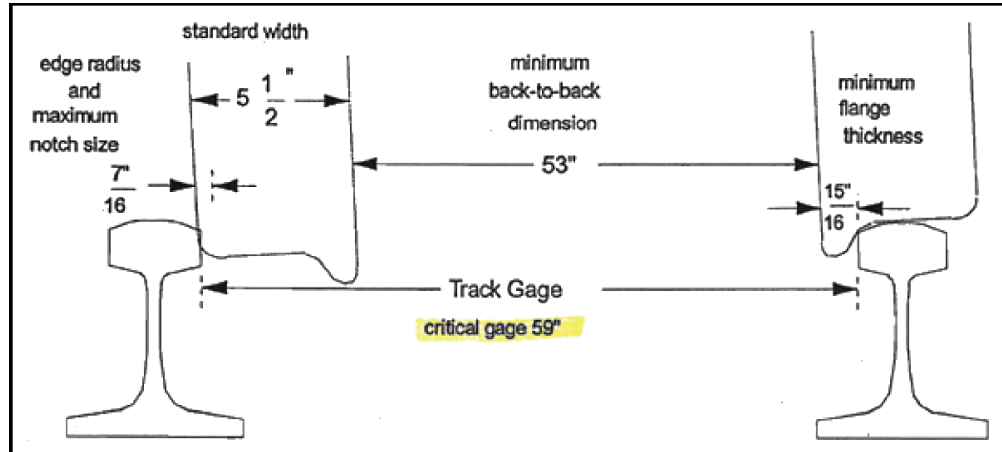
When the loaded gauge exceeds the critical gauge limit of 59 inches defined by the physical dimension of a standard worn freight car wheel set, wheel drop will occur (Figure 4).

Figure 4. Critical gauge for standard worn wheel set (Source: Volpe National Transportation Systems Center)

For the ALP-45DP locomotive, equipped with new wheel sets, the critical rail gauge would be $59 \frac{1}{2}$ inches.

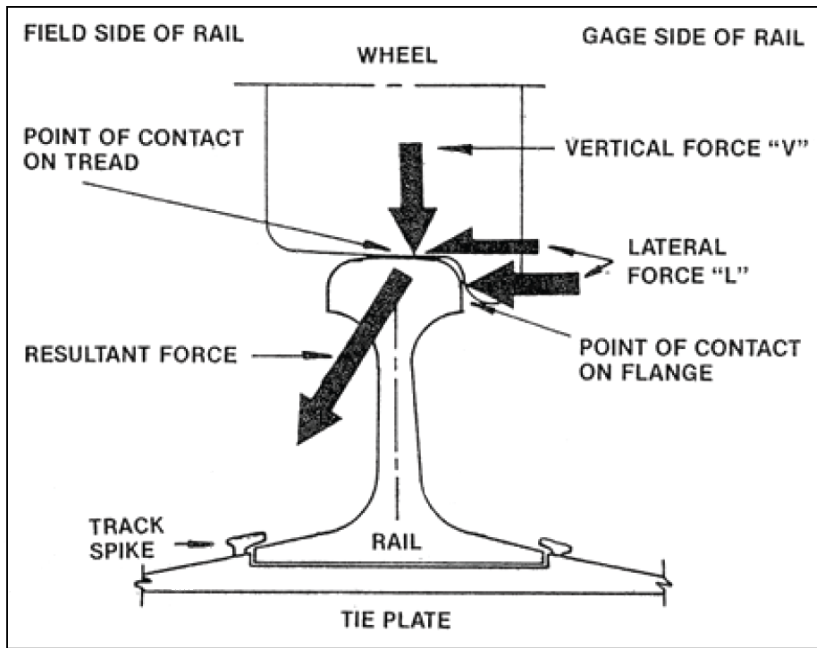
L/V quantifies the ratio between the force of the wheel flange pushing out on the rail (lateral force) and the wheel load of the equipment bearing down on the rail (vertical force). The single wheel L/V ratio can be used to predict the risk of a wheel climbing the gauge face of the rail or lifting off the rail (Figure 5). Similarly, the combined forces for the wheels on one truck side exerting high lateral forces onto the same rail can cause rail-head deflection, reverse-rail cant, or lateral-rail displacement, resulting in gauge spread or rollover. AAR guidelines indicate that truck side L/V values should not exceed 0.6.

Figure 5. Forces between rail and wheel (Source: AAR)

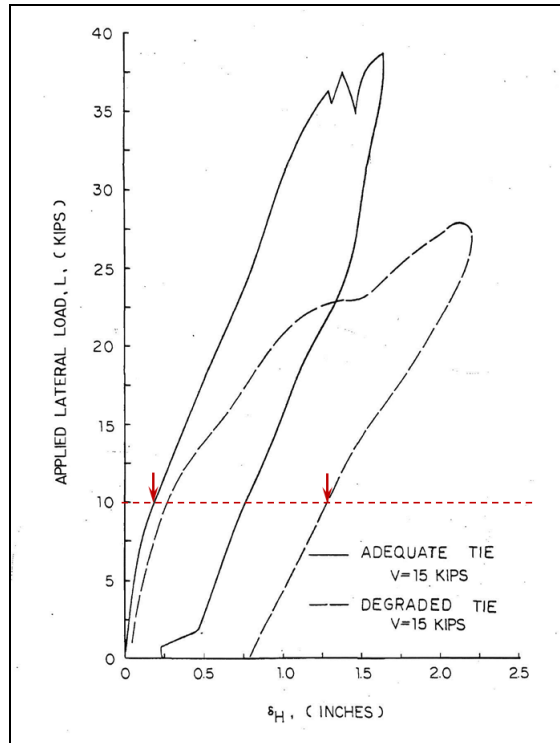
Testing sponsored by the United States Federal Railroad Administration ¹² assessed the amount of rail-head displacement under various loads for different track conditions. For example, the application of a vertical load of 15 000 pounds and a lateral load of 10 000 pounds ($L/V = 0.66$) will result in rail-head displacements between $\frac{1}{8}$ inch and $1 \frac{1}{4}$ inches, depending on tie conditions (Figure 6).

Figure 6. Rail-head deflection under lateral force based on tie conditions (Source: FRA, annotated by TSB)

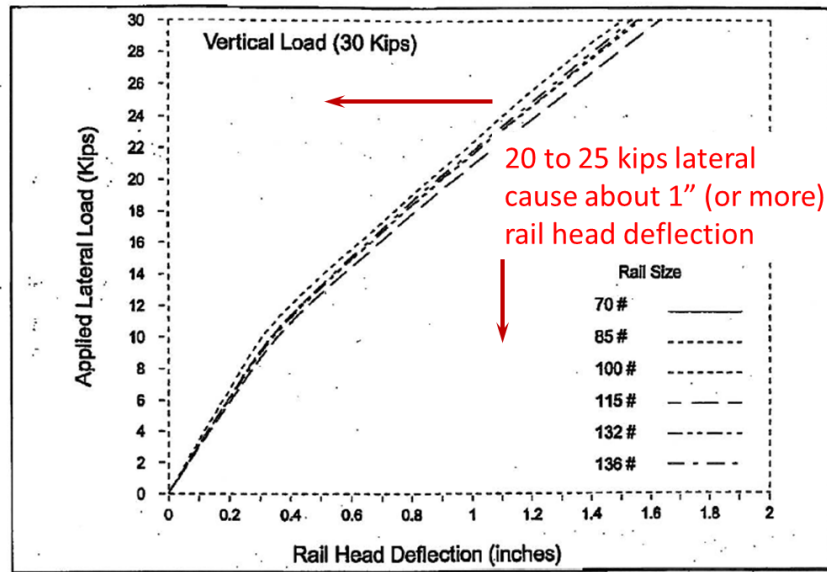
Testing also showed that rail-head deflection is relatively insensitive to the size (weight) of rail. However, head-free rail, due to its lower-lateral stiffness, has more head deflection than other types of rail. With vertical loads of 30 kips, L/V values of 0.7 generate lateral loads of 21 kips, which can cause rail-head deflections of approximately 1 inch (Figure 7).

Figure 7. Rail-head deflection versus applied lateral load on various rail sizes when vertical load equals 30 kips (Source: FRA, annotated by TSB)

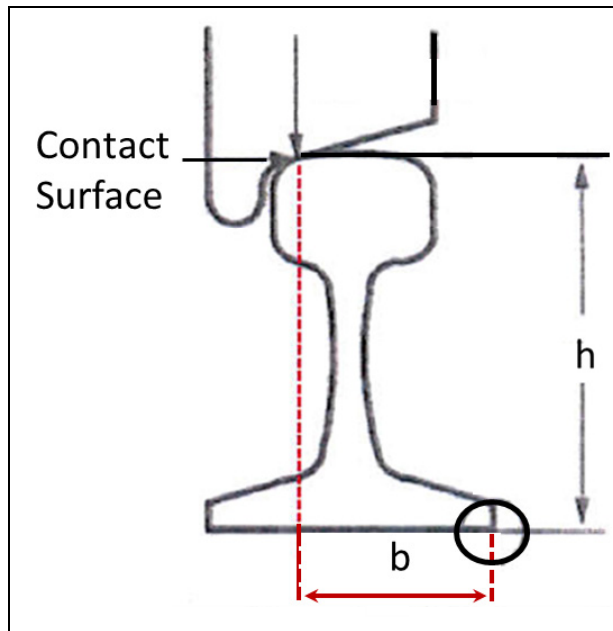
Under lateral loads applied by the wheels, the rail rotates around the field side of the base. The lateral stability of a rail is linked to the b/h ratio between its height and the distance of the application of the wheel load to the field side of the base (Figure 8). Under equilibrium conditions, just before the rail starts to roll, the L/V ratio is equal to b/h .

In normal circumstances, the wheel-to-rail contact surface occurs at the inner gauge corner of the rail head. When the wheel load is shifted towards the field side, b decreases and b/h decreases. Therefore, L/V is also reduced, leading to an increased risk of rail rollover. The b/h ratio can vary from above 0.6 for contact at the gauge side, to approximately 0.2 when the contact surface is at the far-field side.

Figure 8. Rail stability diagram (Source: TUV/RSI)

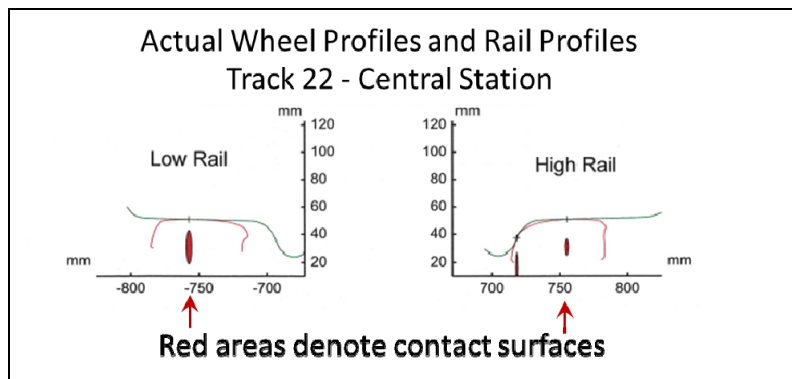
The wheel profiles from locomotive AMT 1352 were compared to the actual rail profiles. Figure 9 identifies the wheel-rail contact points.

Figure 9. Location of lead locomotive wheel contact on rail head for Track 22 (Source: TUV/RSI)

Due to the location of the wheel/rail contact points that is, towards the field side of the rail, the b/h values were calculated to be approximately 0.45.
