**RAILWAY INVESTIGATION REPORT
R11V0257**

MAIN-TRACK DERAILMENT

**CANADIAN PACIFIC RAILWAY
FREIGHT TRAIN CP 353-267
MILE 41.50, MOUNTAIN SUBDIVISION
MOBERLY, BRITISH COLUMBIA
27 DECEMBER 2011**

Report Number R11V0257

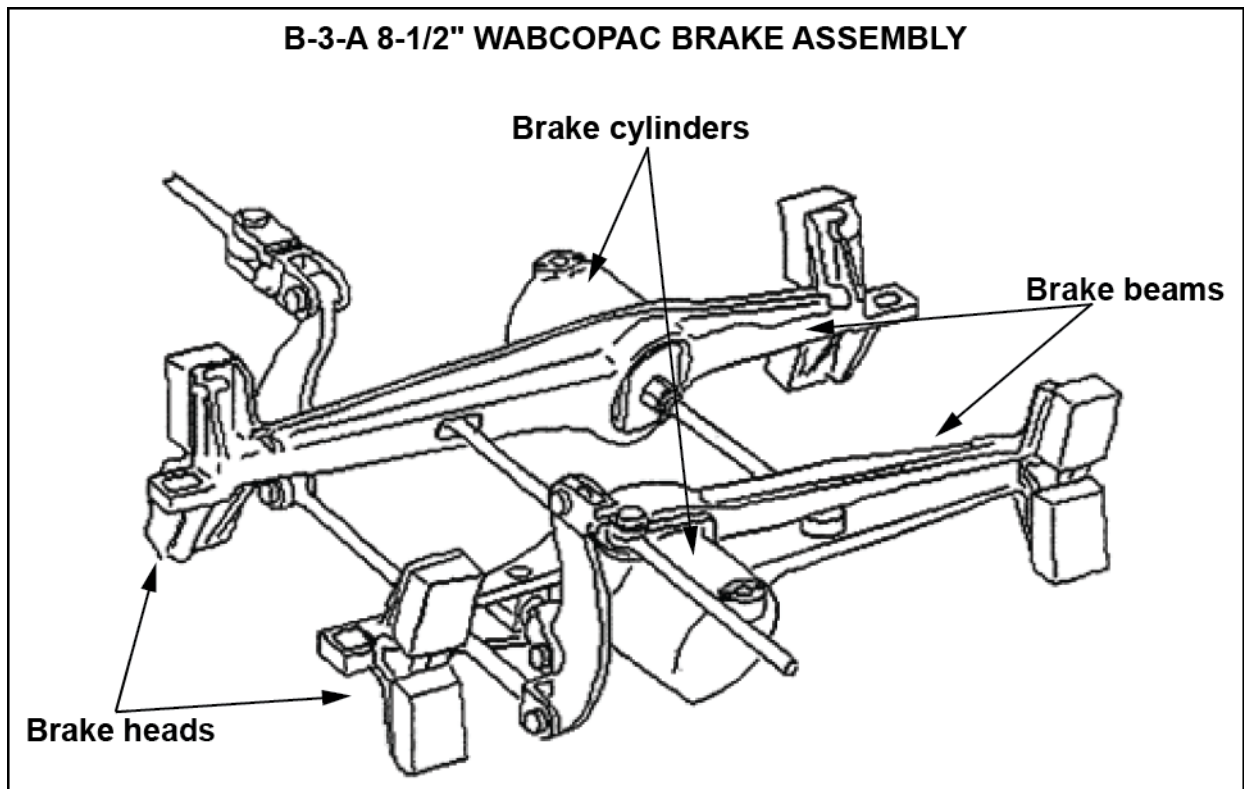
Figure 3. B-3-A WABCOPAC brake assembly

SOO75083 was equipped with B-3-A 8-1/2" WABCOPAC brake assemblies manufactured by Wabtec (Figure 3). The brake assemblies were truck-mounted and each brake beam had a separate brake cylinder. In contrast, a standard brake assembly has a single brake cylinder mounted on the body of the car to operate the brake system.

The No. 2 brake beam (i.e., adjacent to the No. 2 wheel set) was manufactured in January 1978. This brake beam, along with the No. 2 wheel set and the side frames from the B-end truck of the car, was sent to the TSB Engineering Laboratory for detailed analysis.
