RAILWAY INVESTIGATION REPORT R14M0002

MAIN-TRACK DERAILMENT

**CANADIAN NATIONAL
FREIGHT TRAIN M30831-06
MILE 152.60, NAPADOGAN SUBDIVISION
PLASTER ROCK, NEW BRUNSWICK
07 JANUARY 2014**

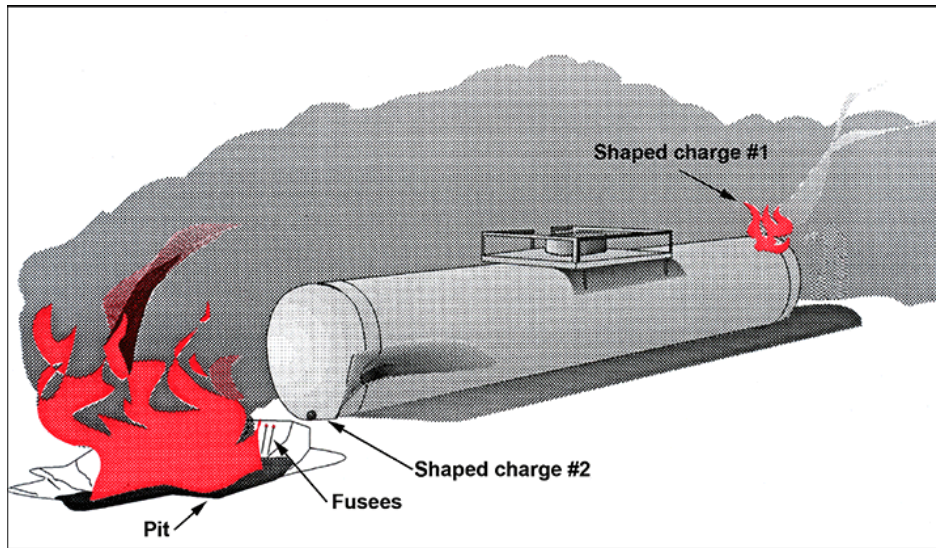
Figure 3. Schematic of vent and burn operation (Source: Transportation Technology Center, Inc.)

The procedure itself involves placing 2 explosive charges on the affected tank car. One charge is placed at the highest point of one of the tank heads, which is typically called the “vapour space.” The other charge is placed at the lowest point of the opposite head of the car, which is typically the “liquid space.” The vapour space charge is first ignited. The charge creates a hole in the tank shell, ignites the vapours as they vent to atmosphere and relieves pressure in the tank. Once the pressure has been relieved, the second charge is ignited. This opens a hole in the liquid space, which allows the liquid to drain out of the tank into a pre-excavated pit area where it is burnt off to atmosphere (Figure 3).
