RAIL TRANSPORTATION SAFETY INVESTIGATION REPORT R19C0015

UNCONTROLLED MOVEMENT OF ROLLING STOCK AND MAIN-TRACK TRAIN DERAILMENT

Canadian Pacific Railway Company
Freight train 301-349
Mile 130.6, Laggan Subdivision
Yoho, British Columbia
04 February 2019

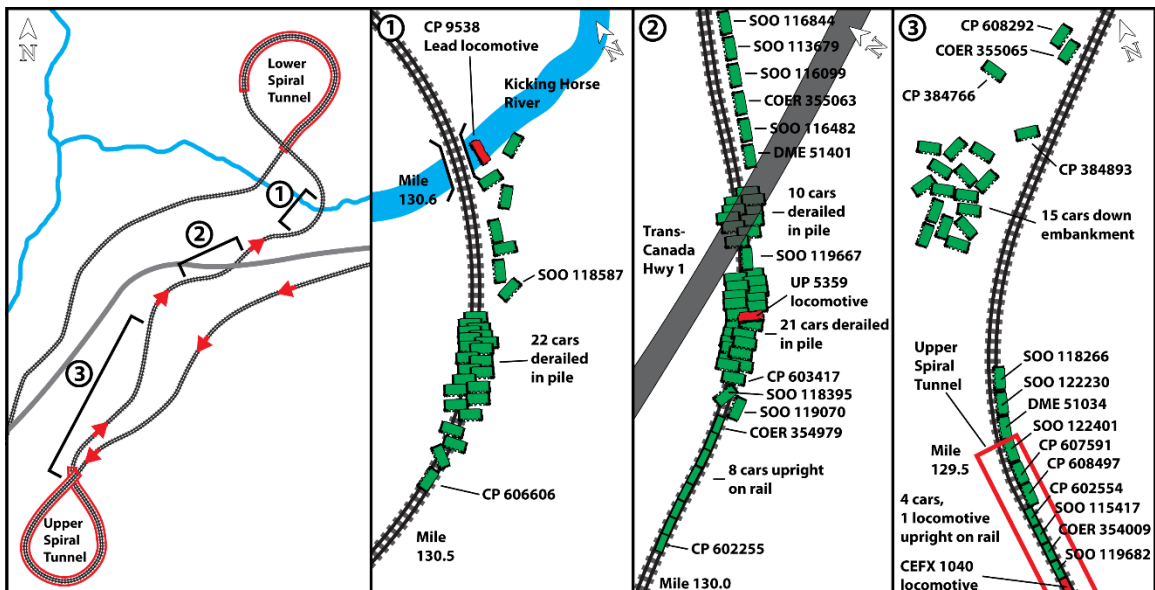
Figure 3. Site diagram showing an overview of the derailment site and close-up views of the 3 sections of the derailment (Source: TSB)

The train had separated into 3 sections during the derailment (Figure 3).

The front portion of the train, including the lead locomotive (CP 9538) and the first 35 cars, had derailed on the curve immediately before the Kicking Horse River bridge at Mile 130.6 (Figure 4).

The head-end locomotive, CP 9538, was lying on its left side in the riverbed, some 35 feet below the track level. The river was quite shallow, and the surface was frozen and covered with snow. A patch of open water about 20 feet in diameter was visible underneath and adjacent to the locomotive, where the ice had broken when the locomotive fell onto the riverbed. An inspection of the underside of the locomotive showed little indication of ground contact, but the rest of the locomotive had sustained extensive damage.

Further back in the train, at around Mile 130.2, 40 cars from the middle portion of the train had derailed on their side and in a pile-up. Several of these cars were underneath a multi-lane overpass structure where Highway 1 passes above the track. Some cars were leaning against the bridge piers, which sustained superficial damage (Figure 5).

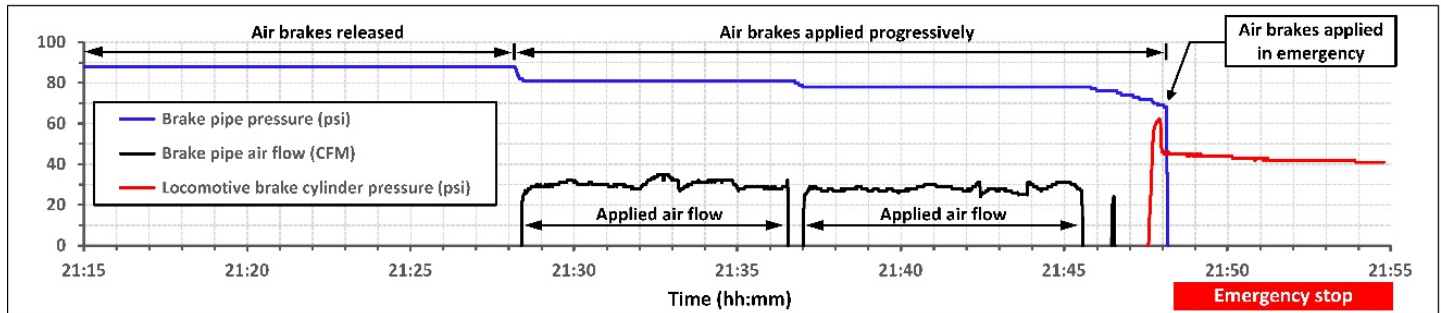
Figure 20. Graph showing the unexpected increase in air flow as the train descended Field Hill (Source: TSB, based on data from the UP 5359 locomotive event recorder)

Data from the event recorder on the UP 5359 mid-train remote locomotive show a sudden and unexpected increase in air flow of up to 35 CFM a few seconds after a brake pipe reduction during the initial descent into Partridge. This is illustrated in Figure 20.

Just prior to the emergency application, 3 incremental brake pipe pressure reductions of 2 psi each were made. However, there was no air flow reading following these reductions because the brake pipe leakage was diminished, due to the following reasons: the brake pipe pressure was reduced; there was not enough time to lap⁵³ the brake pipe reduction and activate the pressure maintaining feature to generate increased air flow; and the total flow was less than 20 CFM.

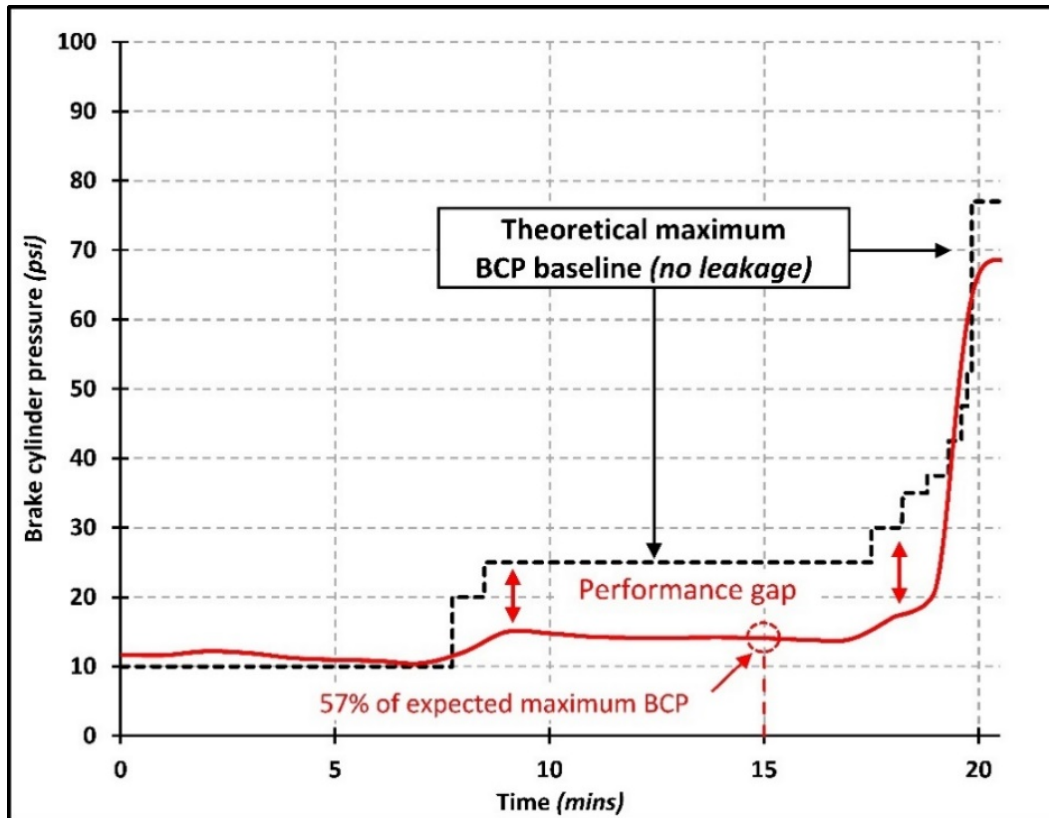
Figure 21. Aggregate brake cylinder pressure for all 13 cars from the 08 February 2019 service brake application test (Source: TSB)

Figure 21 shows how aggregated BCP from the test performed on 08 February 2019, at temperatures of -19°C to -21°C , changed over time. From the test measurements, the average BCP for the 13 recovered cars was calculated and plotted over a 20-minute timeframe (solid line in Figure 21). As reference, the theoretical maximum BCP baseline without leakage is shown as a dashed line.

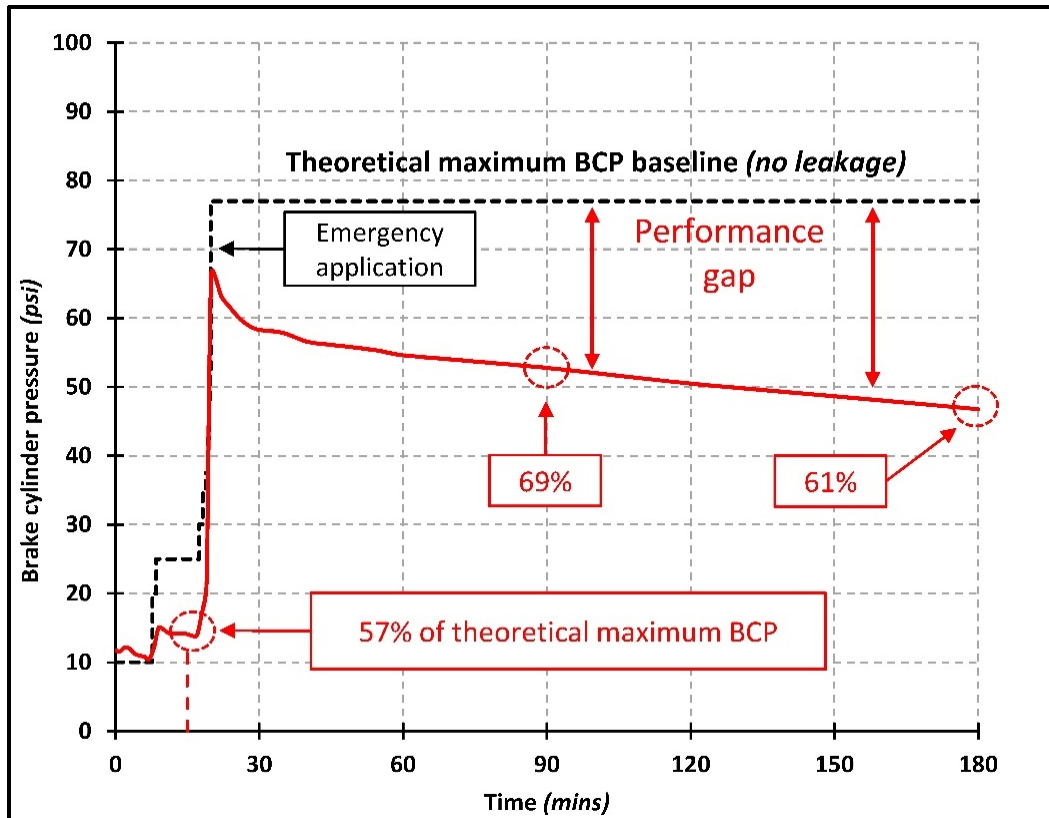
Figure 22. Aggregate brake cylinder pressure for all 13 cars from the 08 February 2019 emergency brake application test (Source: TSB)

All 13 cars responded to the emergency brake application with increased BCP. The test duration was 180 minutes. The average BCP started at 67 psi (87% of the theoretical maximum) and then declined to 47 psi at the end of the test. After 90 minutes, the average BCP was 69% of the emergency brake theoretical maximum. After 180 minutes, the average BCP was 61% of the emergency brake theoretical maximum, and 9 cars (69% of the total cars) had a BCP of at least 50 psi.

Figure 22 shows how aggregated BCP from the test conducted on 08 February 2019 changed over time during the emergency brake application. This figure further extends the time duration expressed in Figure 21 from 20 minutes to 180 minutes (3 hours). From the test measurements, the average BCP for the 13 recovered cars was calculated and plotted.

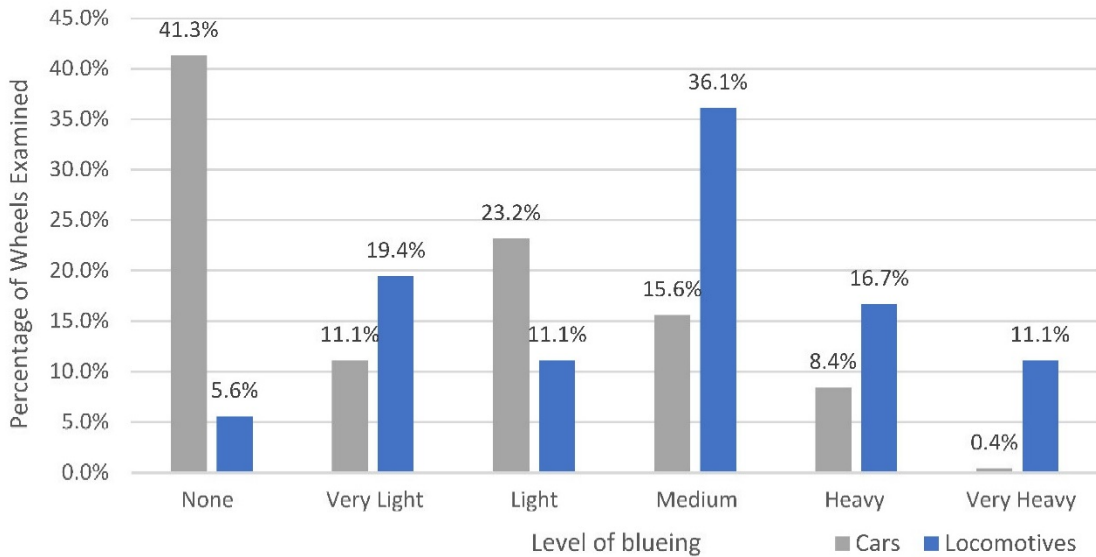
Figure 25. Blueing level of examined wheels, comparing locomotives to cars (Source: TSB)

Figure 25 compares the blueing distribution of the car wheels with the blueing of the locomotive wheels. While the car blueing distribution is skewed to the left (less effective car brakes), the locomotive blueing distribution has a bell shape slightly skewed to the right, suggesting that most of the brakes were operative.

In contrast to the wheels on the cars, the majority of the wheels on the locomotive, almost 64%, had medium, heavy, or very heavy blueing; less than 6% did not have any indication of blueing. High levels of blueing on locomotives can be attributed to the locomotive BCP, which is maintained directly from the locomotive main reservoir whenever the locomotive brakes are applied. When compared to the DP lead locomotive, the 2 DP remote locomotives had less blueing on the wheels, as expected; this is because on the remote locomotives, BCP was being limited to a maximum of 45 psi after the emergency brake application (as opposed to 72 psi for the lead locomotive).

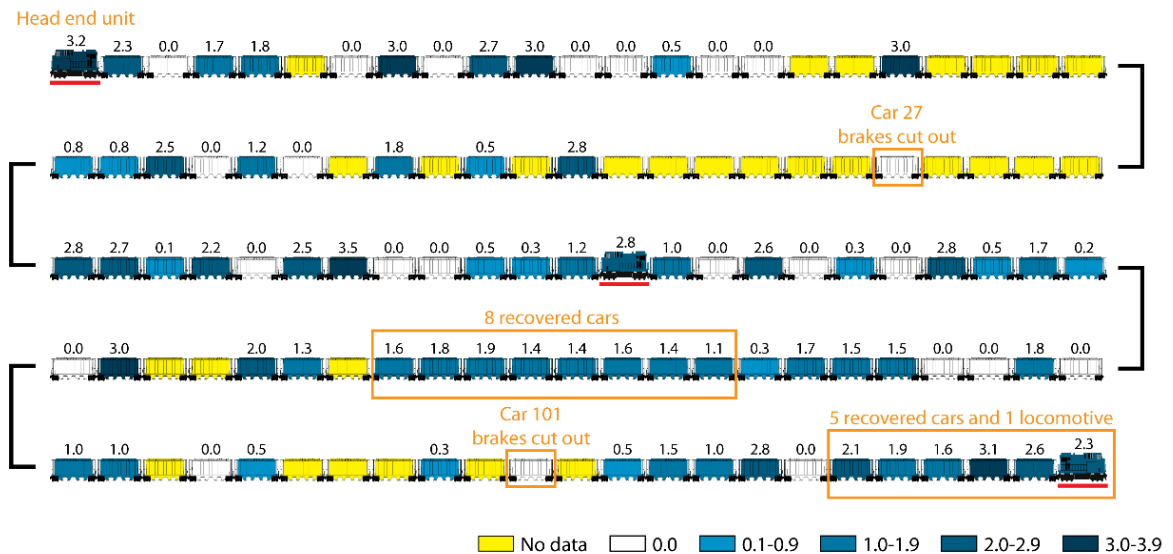
Figure 26. Pictorial representation of blueing on the occurrence train* (Source: TSB)

The serial numbers were collected from the inside hub of each set of wheels and were cross-referenced with the car numbers and axle position of each examined wheelset. Figure 26 shows the level of blueing of the wheels on each car and locomotive in the train. The shade of blue depicts the level of blueing observed; no data were available for the cars in yellow. Data were not available for all of the car wheels; therefore, an average value (per car) was used in all cases. Blueing levels tended to be random throughout the train. There were 35 grain cars that had wheels showing no blueing or blueing level 1 (very light blueing).

* The blueing scale on this image is 0 to 3.9 instead of 0 to 5 because the number for each car is the average of all the wheels examined on that car.

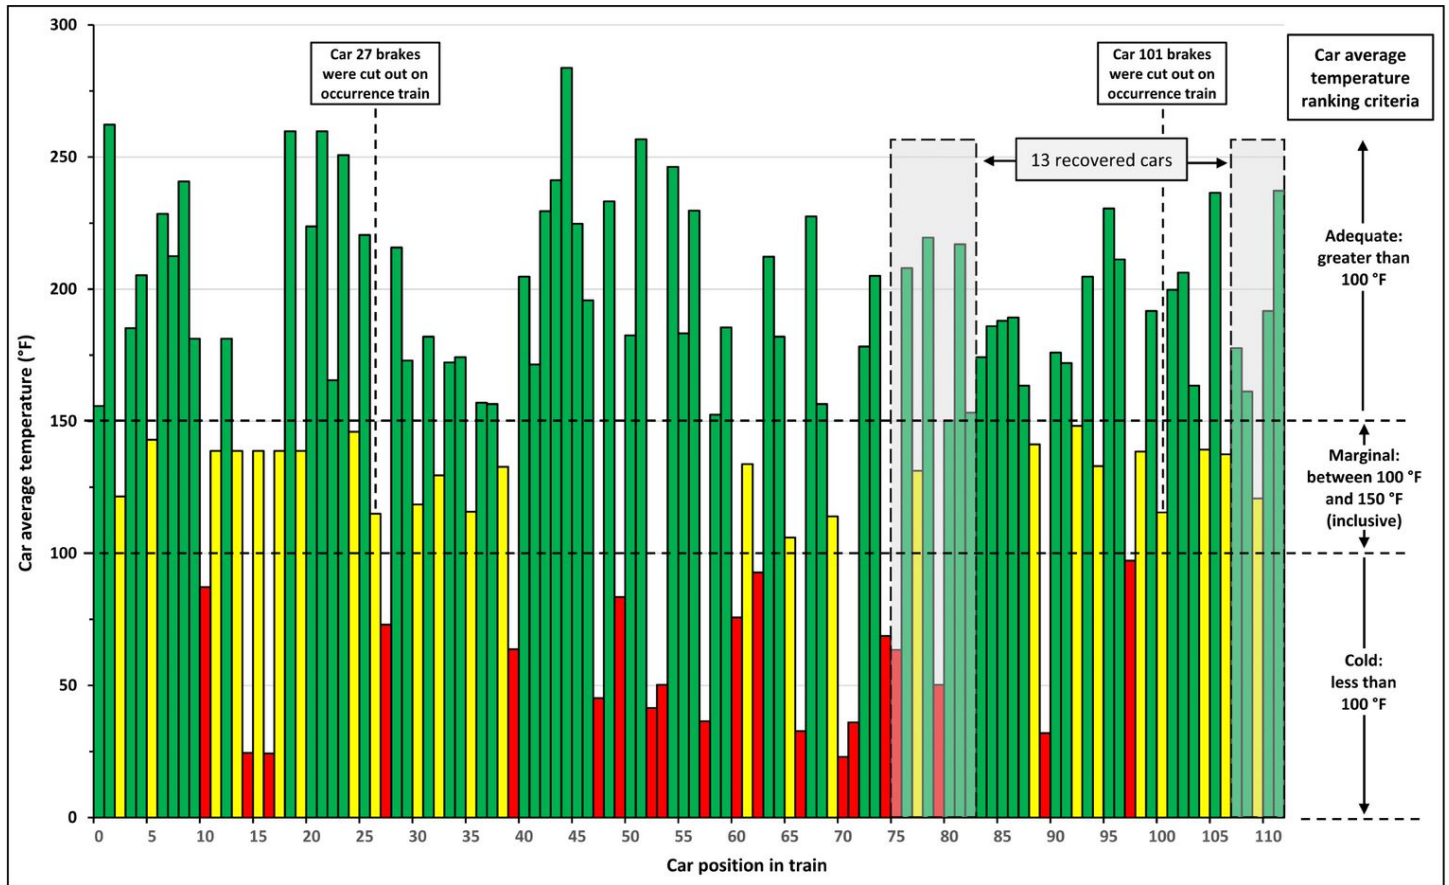
Figure 27. Average car temperature for the 112 cars on the train, based on data from the wheel temperature detector at Mile 111.7 (Source: TSB)

Using data obtained from the WTD at Mile 111.7, Figure 27 shows the average temperature for each of the 112 cars on the train from the head end (left) to the tail end (right). The cars are shown in different colours based on their average temperature, to reflect their respective ranking in terms of brake effectiveness. As the figure illustrates, there were significant differences in car temperature, and several of the cars had an average well below 100 °F, a clear indication that their brakes were either ineffective or completely inoperative.

- * Cars in position 27 and 101 had their brakes cut out on the day of the occurrence, and therefore did not contribute to the train’s braking capacity.
- ** The average car temperatures conveyed in the figure are based on warmer ambient temperatures than on the day of the occurrence.

Table 11 shows the number and percentage of cars and the average temperature⁶⁹ in the 3 different ranking groups. At the Mile 111.7 detector, 60% of cars had adequate braking, 22% had marginal braking performance, and 18% had inoperative braking systems.

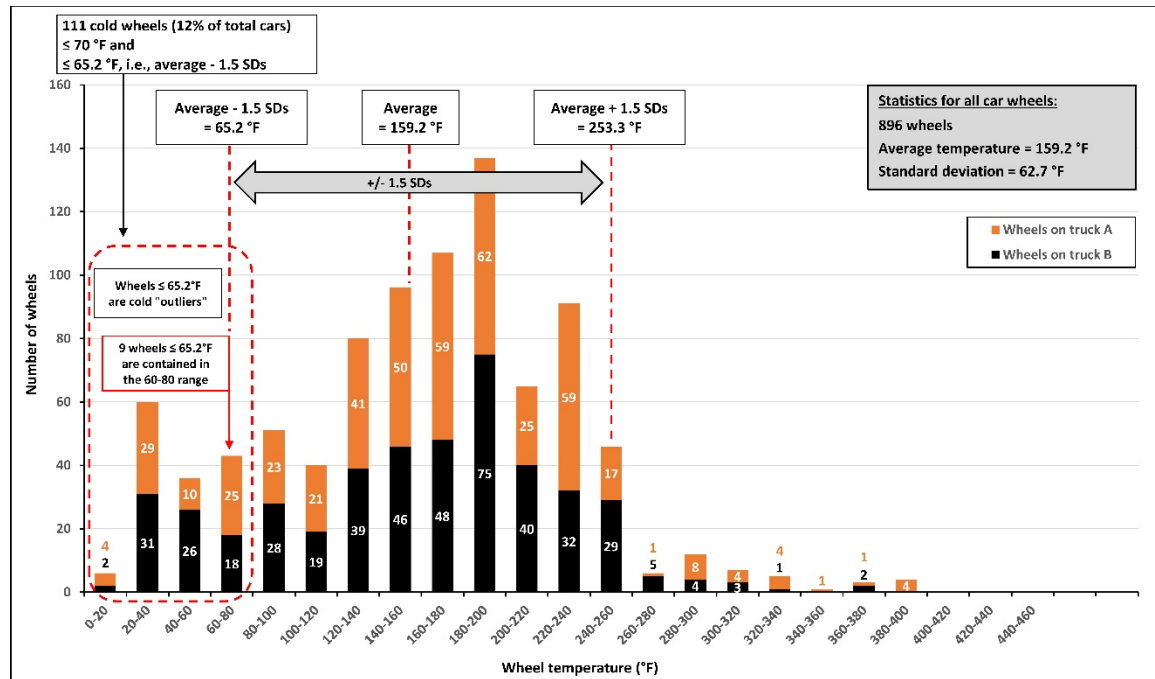
Figure 30. Wheel distribution by temperature range for the cars on the occurrence train, based on the data obtained from the detector at Mile 111.7 (Source: TSB)

However, the criterion of less than 3 SDs would give a negative threshold value in the case of the cars that comprised the occurrence train, due to the low average car temperatures and the large spread of temperatures between cars, as compared to the WTD data for coal trains. Consequently, for the purposes of this investigation, a car average temperature threshold of 1.5 SDs from the average is more meaningful and provides reasonable representation of the braking performance. The use of 1.5 SDs is one of the methods recommended by the NRC in its preliminary scoping study of ATBE. For the occurrence train, 1.5 SDs from the overall average wheel temperature corresponds to 65.2 °F.

Figure 30 is a histogram of the wheel distribution by temperature range for all 896 wheels, based on data obtained from the WTD at Mile 111.7 of the Mountain Subdivision. The large double-headed arrow shows the band of temperatures that are within 1.5 SDs (i.e., 94.1 °F) on either side of the average wheel temperature (i.e., 159.2 °F).

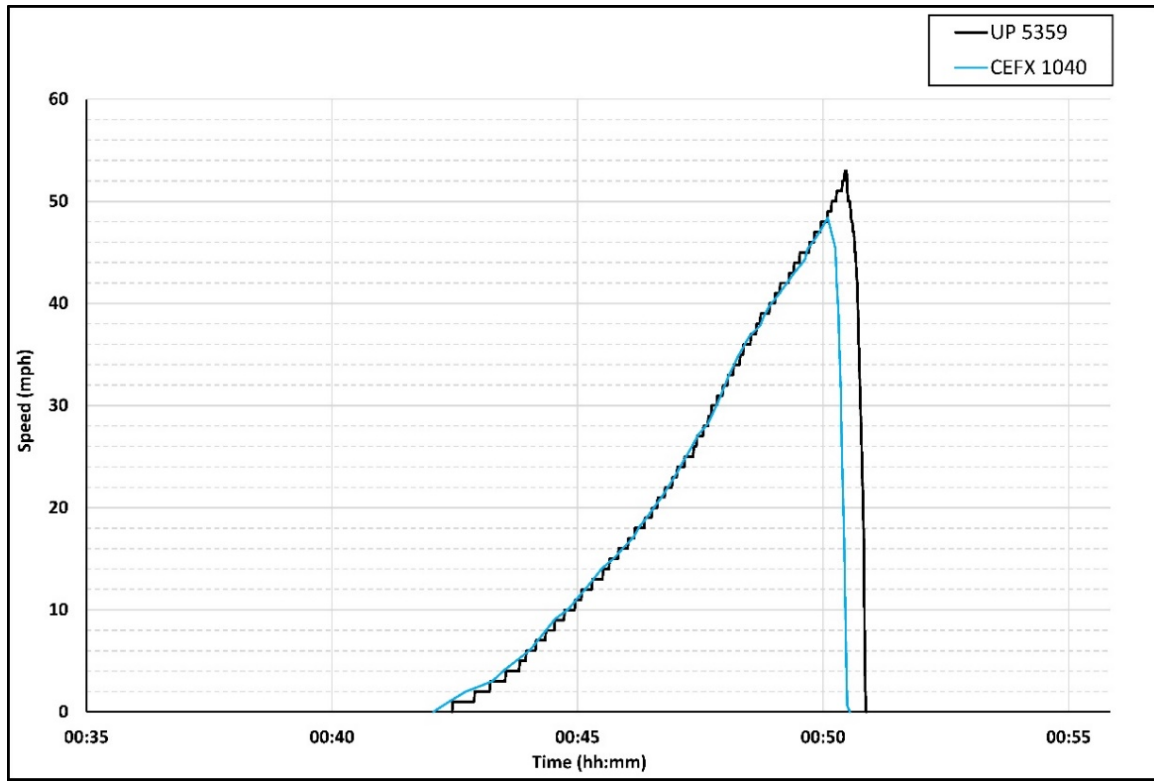
Figure 31. Speed profiles from the locomotive event recorder for the mid-train locomotive (UP 5359) and rear locomotive (CEFX 1040) during the uncontrolled movement (Source: TSB)

From the time the train started to roll on its own with the train brakes applied in emergency, up to when it derailed at a speed of about 53 mph, about 8.5 minutes elapsed. Figure 31 shows the LER speed profile plotted over this time period for the DP mid-train locomotive (UP 5359) and for the DP rear locomotive (CEFX 1040). The data from CEFX 1040 show that the speed of the rear locomotive dropped rapidly from about 48 mph to 0 mph when the rear portion of the train derailed. The data from UP 5359 show that, about 23 seconds later, the speed of the mid-train locomotive dropped rapidly from 53 mph to 0 mph as the middle portion of the train derailed. The data from the UP 5359 are shown as a stepped line because the LER captured speed as an integer value, whereas the CEFX 1040 LER captured speed to 1 decimal point.

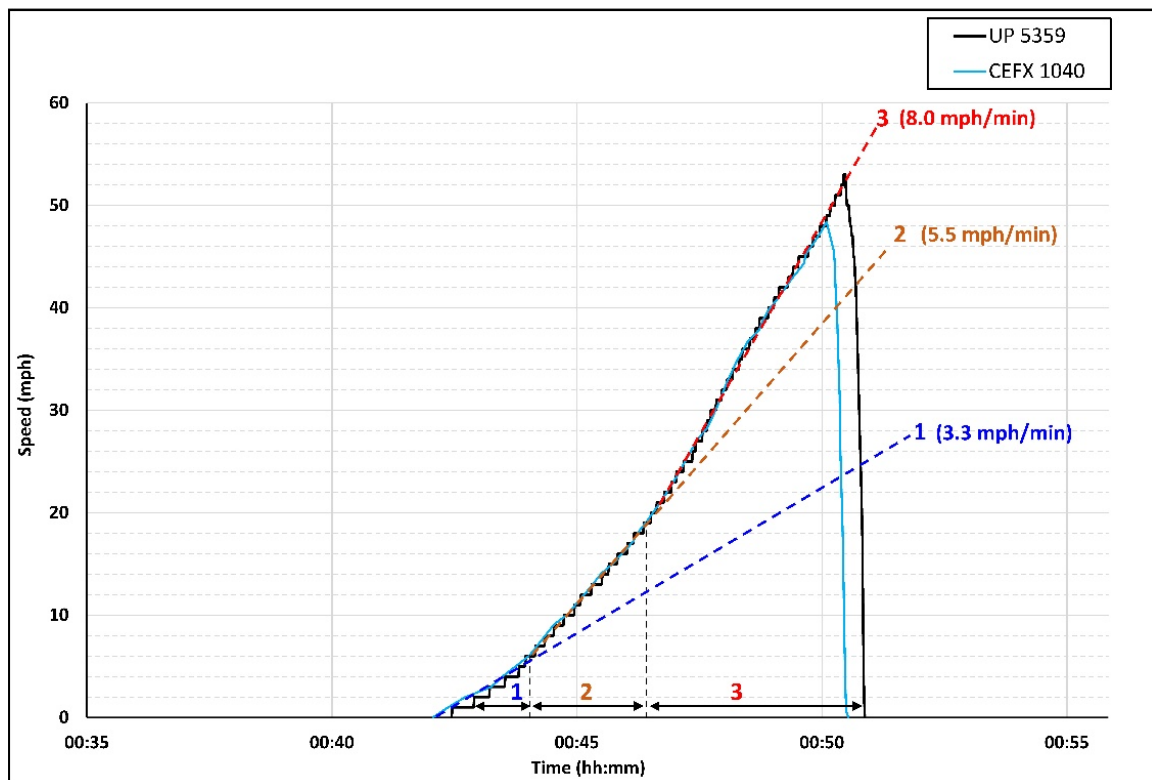
Figure 32. Trend lines for the 3 distinct accelerations during the uncontrolled movement (Source: TSB)

The trend lines are labeled 1 to 3 and indicate a higher acceleration with increasing trend line number:

- Trend line 1 illustrates that the train had a constant acceleration of 3.3 mph/min during the first 2 minutes and 1 second while the speed increased from 0.0 mph to 6.1 mph. Throughout this speed range, a higher brake shoe friction is inherently expected. Thus, the acceleration trend line is not as steep as it is for trend line 2.
- Trend line 2 illustrates that the acceleration remained constant at 5.5 mph/min during the next 2 minutes and 23 seconds while the speed increased from 6.1 mph to 19.1 mph. In this speed range, the initial amount of brake shoe friction will decrease and, in the absence of friction fade, is normally expected to start levelling out and gradually reach a near constant amount of friction.

- Trend line 3 illustrates that the acceleration remained constant at 8.0 mph/min during the last 4 minutes and 2 seconds while the speed increased significantly from 19.1 mph to 53 mph, at which point the lead locomotive derailed. During this time, the wheel tread surface and brake shoe temperatures would have quickly increased, and continued to increase (on the cars that were providing a high brake shoe force, i.e., the cars with a BCP of 50 psi or more), creating the conditions that lead to friction fade.

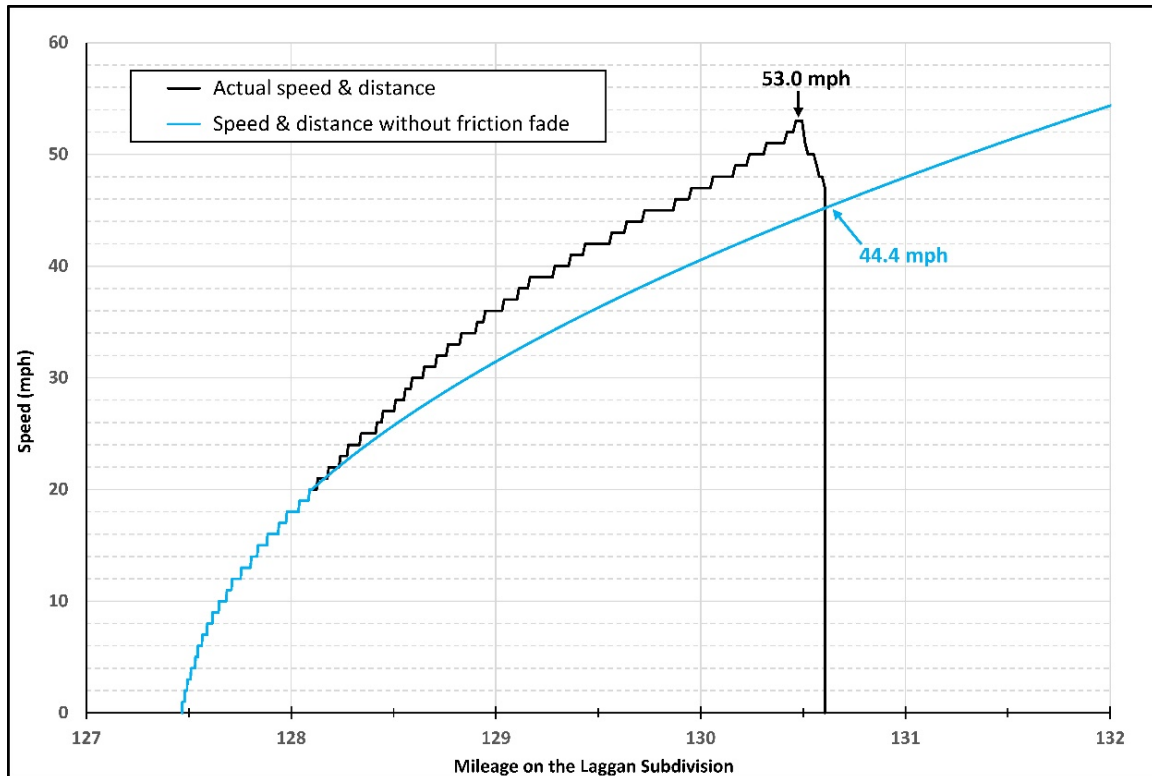
Figure 33. Calculated speeds for lead locomotive with and without friction fade (Source: TSB)

Figure 33 shows speed versus distance plots for the lead locomotive with, and without, friction fade. The values for the actual speed and distance traveled were captured by the UP 5359 LER, but with the distance offset by 3349 feet to represent the actual location of the lead locomotive in the train (instead of the mid-train locomotive). As the figure illustrates:

- In this occurrence, the lead locomotive attained the maximum speed of 53 mph just before arriving at the Kicking Horse River bridge; friction fade was present and the train was accelerating at 8.0 mph/min.
- Had friction fade not been present, the increase in speed would have occurred at the slower rate of 5.5 mph/min, and the train's speed at the Kicking Horse River bridge would have been 44.4 mph, a reduction of 8.6 mph.

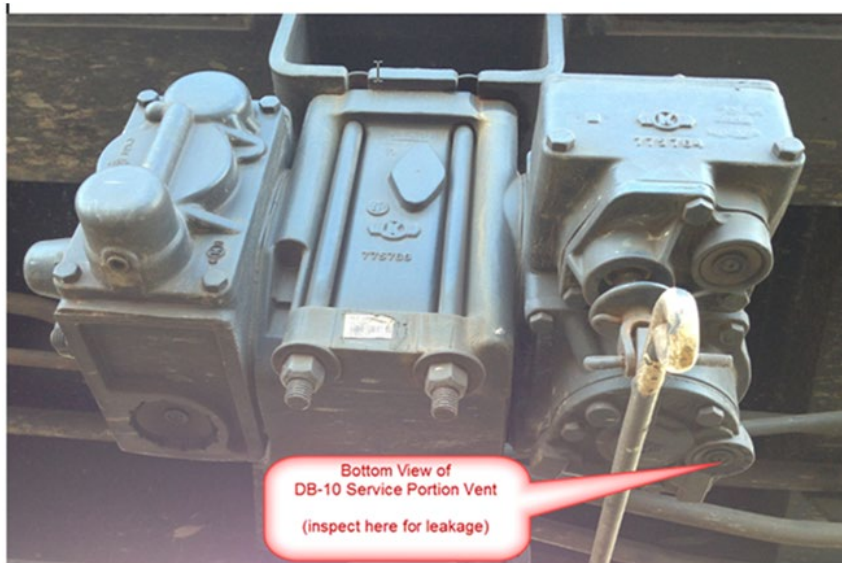
Figure 34. Bottom view of DB-10 service portion showing the bottom cover exhaust port (Source: New York Air Brake)

The NYAB general letter described a condition characterized by increased brake pipe air flow and auxiliary reservoir leakage after applying the brakes. The increased air flow was caused by leakage from the bottom cover exhaust port of the DB-10 service portion due to a worn rubber seal (Figure 34).

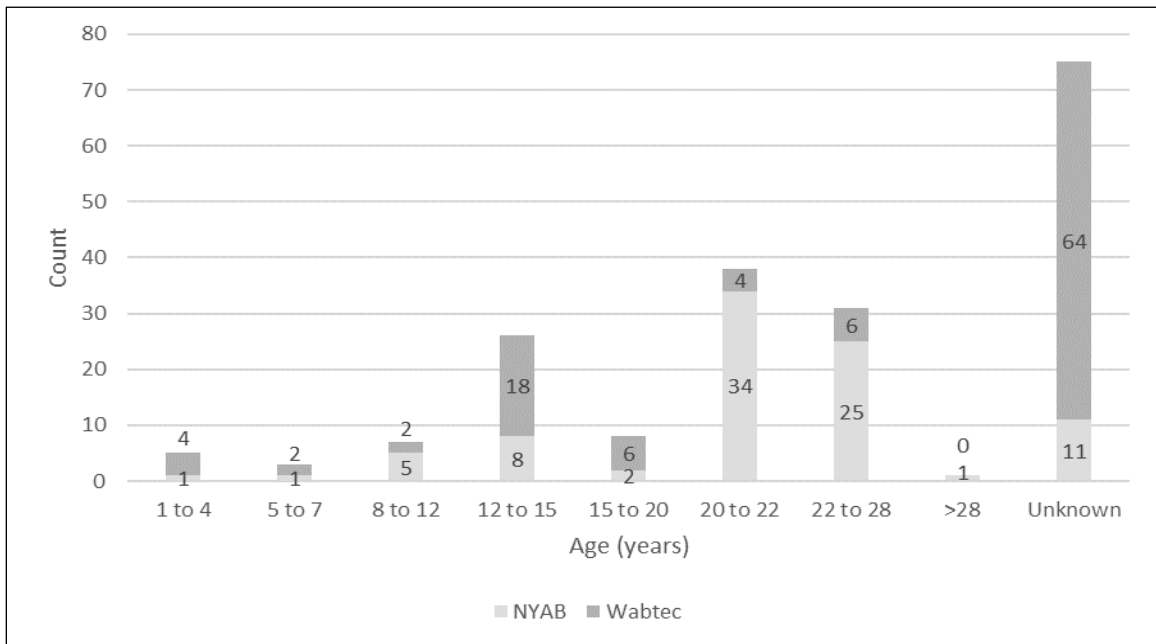
Figure 35. Distribution of the control valve portions by age and manufacturer (Source: TSB)

According to the age ranges provided by the manufacturers, 78 portions on the occurrence train with known dates of manufacture were older than 15 years (Figure 35). Wabtec introduced OEM ID tags and serial numbers only after 1996, which suggests that the Wabtec portions with no OEM ID tags were likely manufactured prior to that date. When the Wabtec portions with no OEM ID tags are added to the 78 portions mentioned above, the total number of portions older than 15 years is 142 (63% of the total).

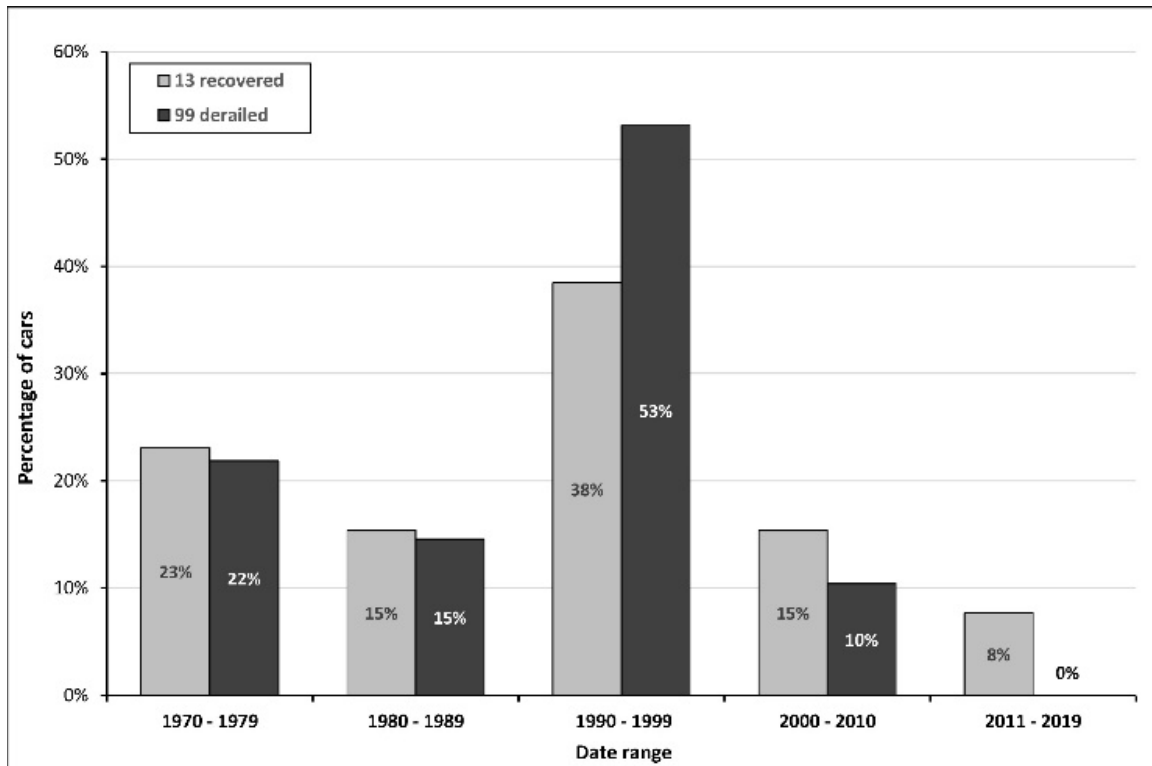
Figure 36. Age of derailed and recovered cars from the occurrence train (Source: TSB, using data from the Universal Machine Language Equipment Register (UMLER) database, maintained by the Association of American Railroads)

As Figure 36 shows, the recovered cars were similar in age to the derailed cars. This was confirmed by an independent-samples Student's *t*-test, which showed that there was no significant difference in the ages of recovered cars ($M=26.1$ years, $SD=12.8$ years) and derailed cars ($M=27.9$ years, $SD=10.1$); $t(107)=0.602$, $p = 0.549$.⁹⁵

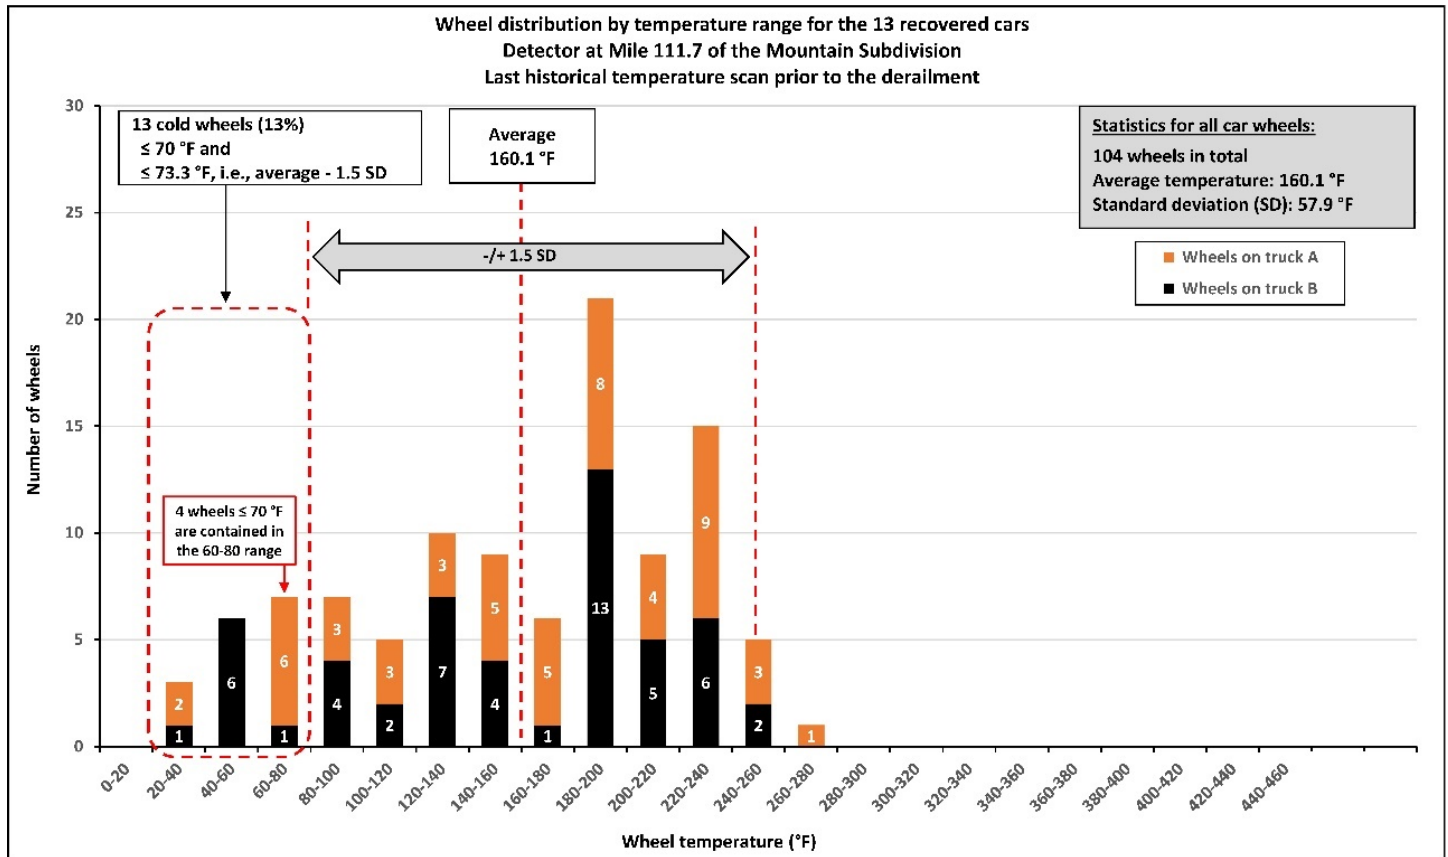
Figure 37. Wheel distribution by temperature range for the 13 recovered cars (Source: TSB)

Data from the Mile 111.7 WTD for the 13 recovered cars and the 99 derailed cars destroyed in the derailment were compared. Their summary statistics are presented in Table 18, and a histogram of the wheel distribution by temperature range for both groups of cars is shown in figures 37 and 38.

Rail cars	Average wheel temperature (°F)	Standard deviation (°F)	Total wheels	Cold wheels
13 recovered cars	160.1	57.9	104	13 (13%)
99 derailed cars	159.1	63.6	792	99 (13%)

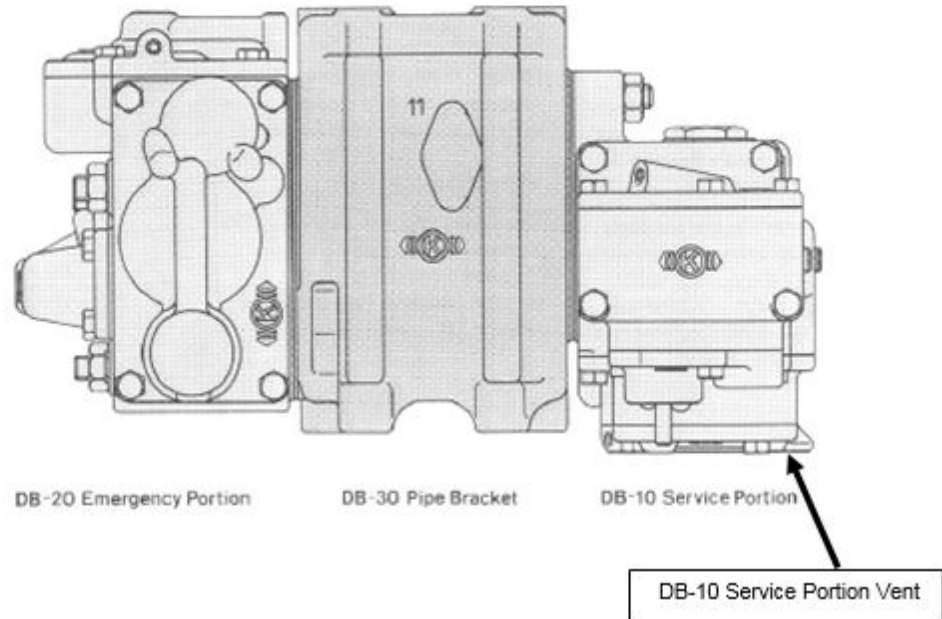
General Letter: Cold Temperature DB-10 Auxiliary Reservoir Leakage

NYAB has been investigating concerns from several railroads regarding low temperature air brake operating issues which could cause train delays in yards and terminals: at a train level, evidence of the symptom begins with increased Brake Pipe air flow from the controlling (Lead) locomotive after a brake application has been initiated. This increased head end air flow is caused by leakage from the bottom cover exhaust port of the DB-10 Service Portion on the brake control valve.

- Observe: Car brakes apply, but air blows from the bottom vent of the DB-10 Service Portion
- Trains experiencing high air flow with the brakes applied should be inspected for the presence of suspect DB-10 Service Portions
- Dragging brake condition is sensed or observed during train operation

Any valve portion experiencing one or more of the described symptoms should be removed from service as soon as practical and refurbished per New York Air Brake Maintenance Specification NYR-332.
