# RAIL TRANSPORTATION SAFETY INVESTIGATION REPORT R19T0191

## **CROSSING ACCIDENT**

Metrolinx  
GO Transit commuter train 3919  
Mile 62.08, Guelph Subdivision  
Kitchener, Ontario  
13 November 2019

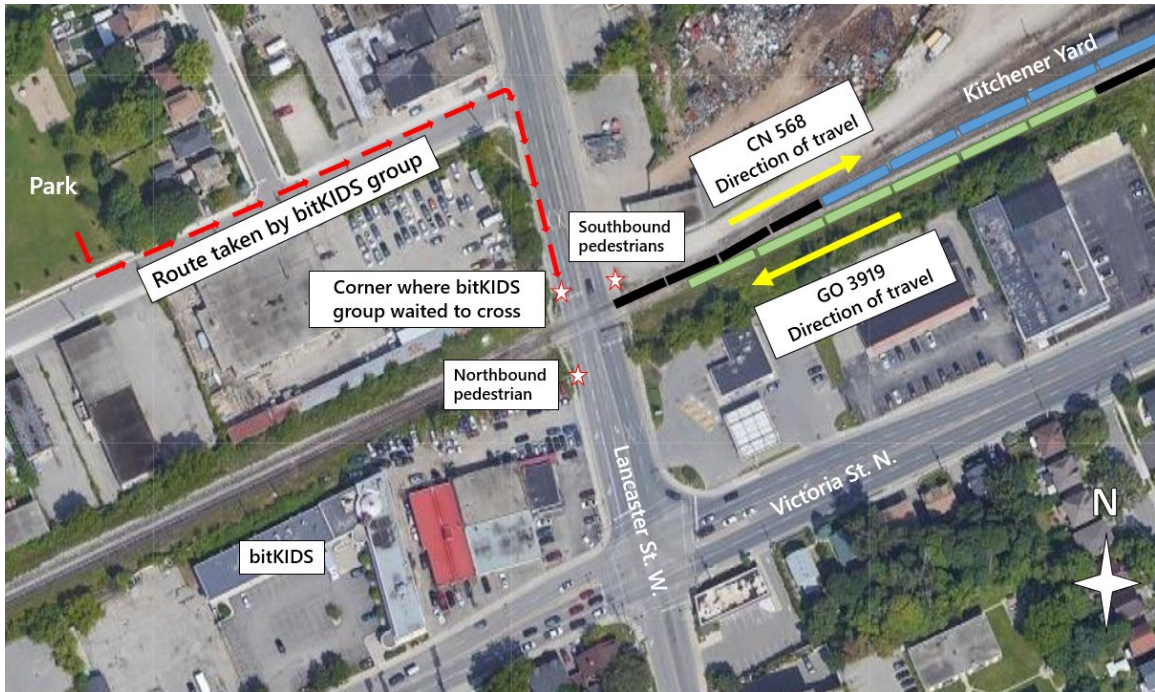
Figure S1. Map of the occurrence site showing the location of the pedestrians and the direction of travel of the trains (Source: Google Earth, with TSB annotations)

The group of pedestrians stopped at the crossing and stood on the northwest quadrant sidewalk for an estimated 5 to 10 minutes in cold weather to wait for CN freight train L56831-13 (CN 568) to clear the crossing as it slowly shoved eastward on the north track, back into Kitchener Yard. Just as CN 568 had nearly cleared the east end of the crossing, a pedestrian waiting on the southwest quadrant sidewalk walked northward over the crossing, toward the group of 11 pedestrians on the northwest quadrant sidewalk, while the GCWD were still activated (Figure 1).

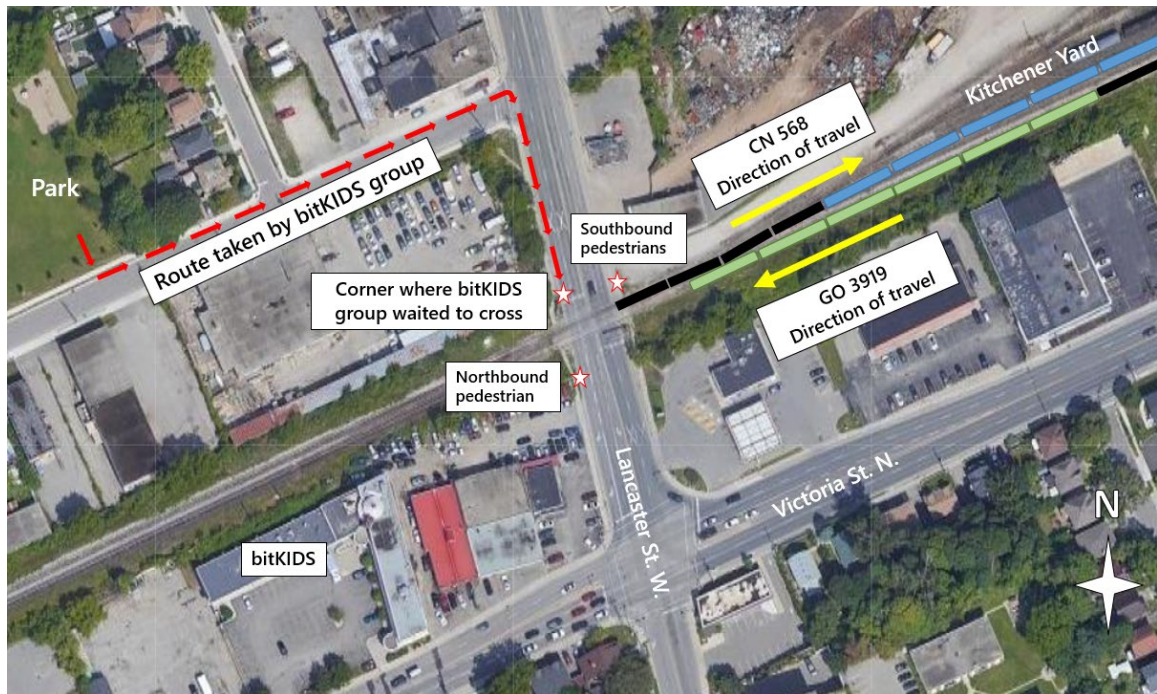
Figure 1. Map of the occurrence site showing the location of the pedestrians and the direction of travel of the trains (Source: Google Earth, with TSB annotations)

The north track was occupied by CN freight train L56831-13 (CN 568), which was backing up into the yard. The group of 6 adult therapists and 5 child clients waited on the northwest quadrant sidewalk for an estimated 5 to 10 minutes in cold weather for CN 568 to slowly clear the crossing and the GCWD to deactivate (Figure 1).

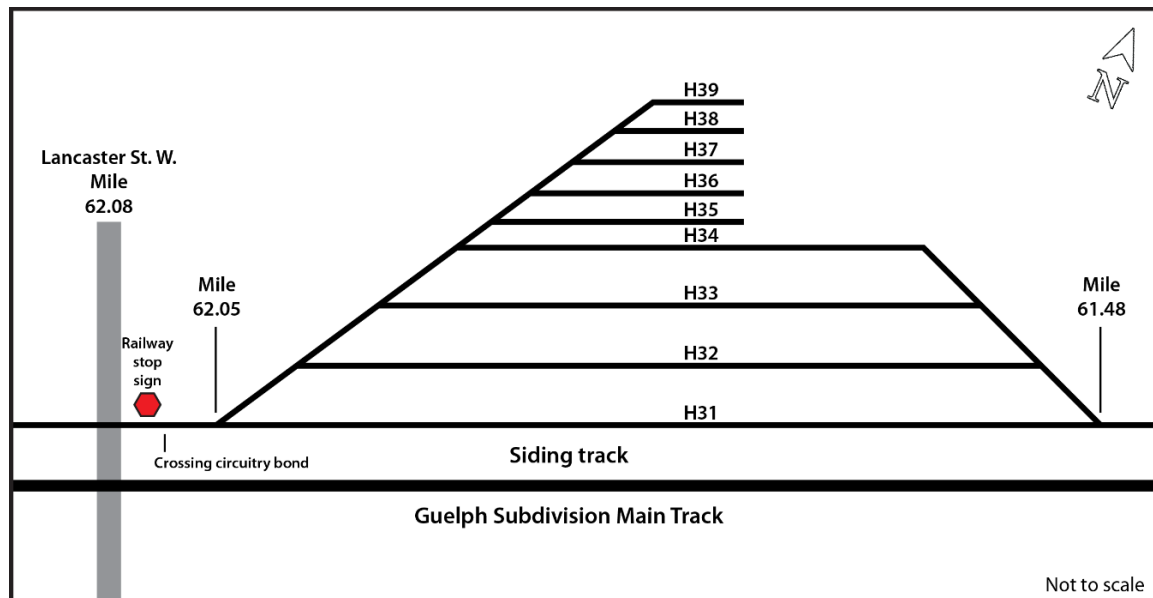
Figure 5. Schematic of Canadian National Railway Company's Kitchener Yard near the Lancaster Street West crossing (Source: TSB)

CN operates the yard east of Lancaster Street West (Figure 5). It is a busy switching yard with movements often occupying the siding and the crossing.

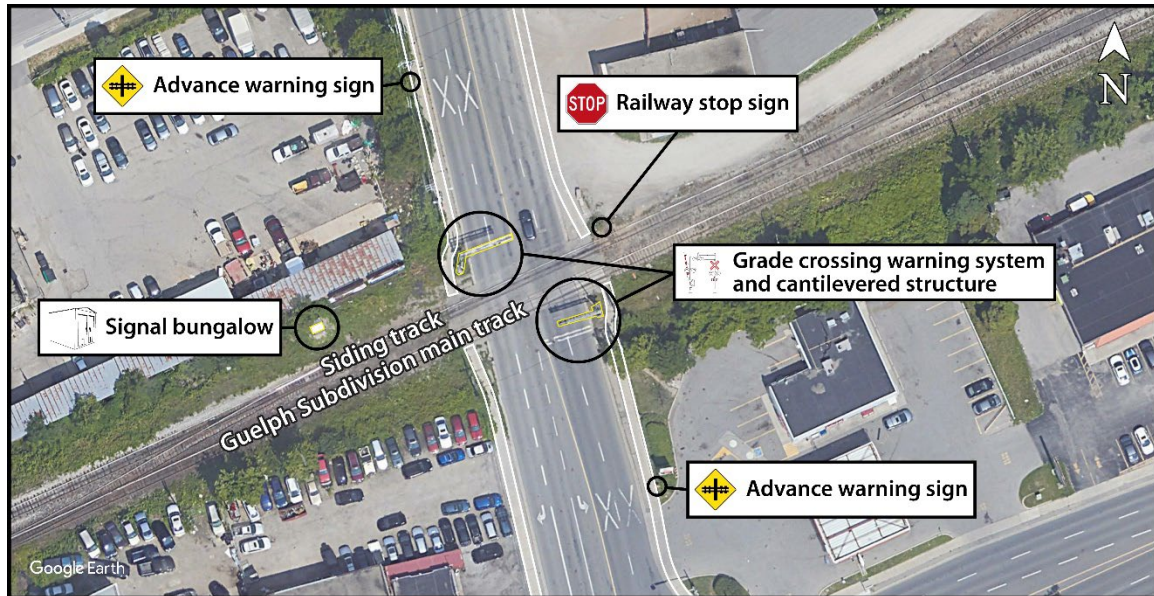
Figure 6. Lancaster Street West crossing (Source: Google Maps, with TSB annotations)

Lancaster Street West is a paved 4-lane roadway, generally oriented in a north–south direction, that intersects the Guelph Subdivision at approximately 80 degrees (Figure 6).

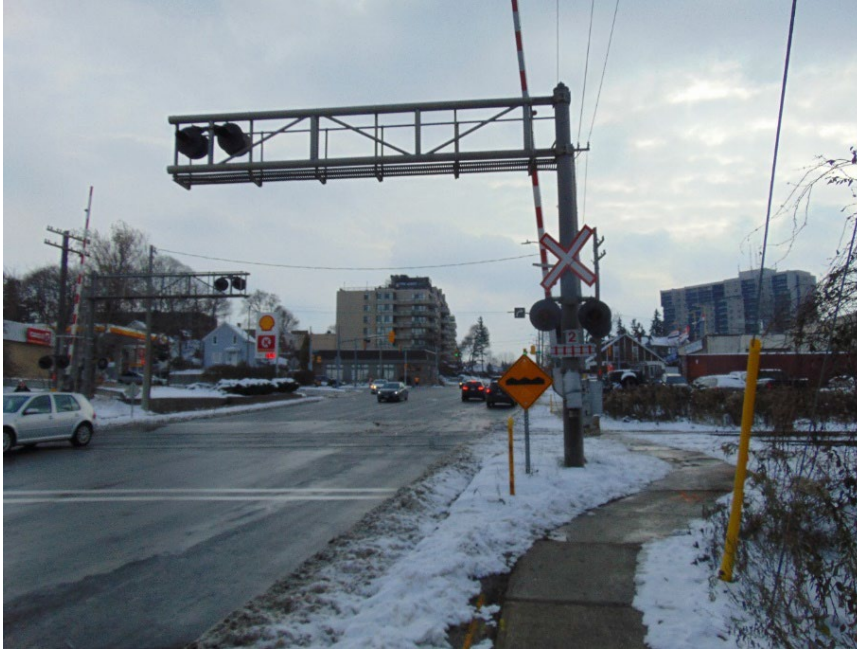
Figure 7. Lancaster Street West crossing, looking south (Source: TSB)

The GCWD consist of standard railway crossing signs, flashing lights, bells, and gates that extend over the roadway surface. Additional flashing lights are mounted on cantilevered structures extending over the outside lanes of Lancaster Street West (Figure 7). The crossing lights flash and the bells sound starting approximately 11 seconds before the gates begin to descend. The crossing gates take approximately 11 seconds to descend fully. For trains on the main track, the gates are horizontal for at least 20 seconds before a train arrives at the crossing. The gates begin to ascend approximately 8 seconds after a train has cleared the crossing.
