# RAIL TRANSPORTATION SAFETY INVESTIGATION REPORT R23D0011

## CROSSING COLLISION

Réseau de transport métropolitain  
Commuter train EXO 816  
Mile 62.18, Canadian National Railway Company  
St-Hyacinthe Subdivision  
Saint-Bruno-de-Montarville, Quebec  
27 January 2023

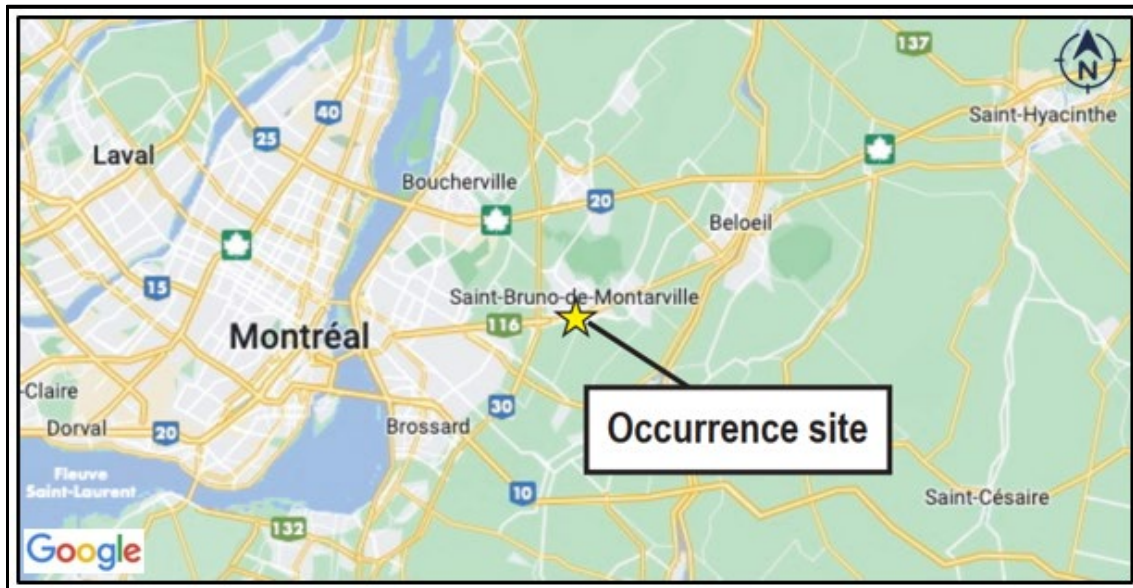
The train, travelling east on the north main track, had just left Saint-Bruno Station (Mile 63.8) in Saint-Bruno-de-Montarville, Quebec. At approximately 1758,<sup>2</sup> the train was approaching the public crossing at Seigneurial Boulevard West (Mile 62.18) at a speed of 62 mph (Figure 1).

Figure 1. Map of the occurrence site (Source: Google Maps, with TSB annotations)
