RAILWAY INVESTIGATION REPORT

R99T0256

DERAILMENT

CANADIAN NATIONAL
FREIGHT TRAIN NO. M304-41-21
MILE 202.98, BALA SUBDIVISION
NEAR BRITT, ONTARIO
23 SEPTEMBER 1999

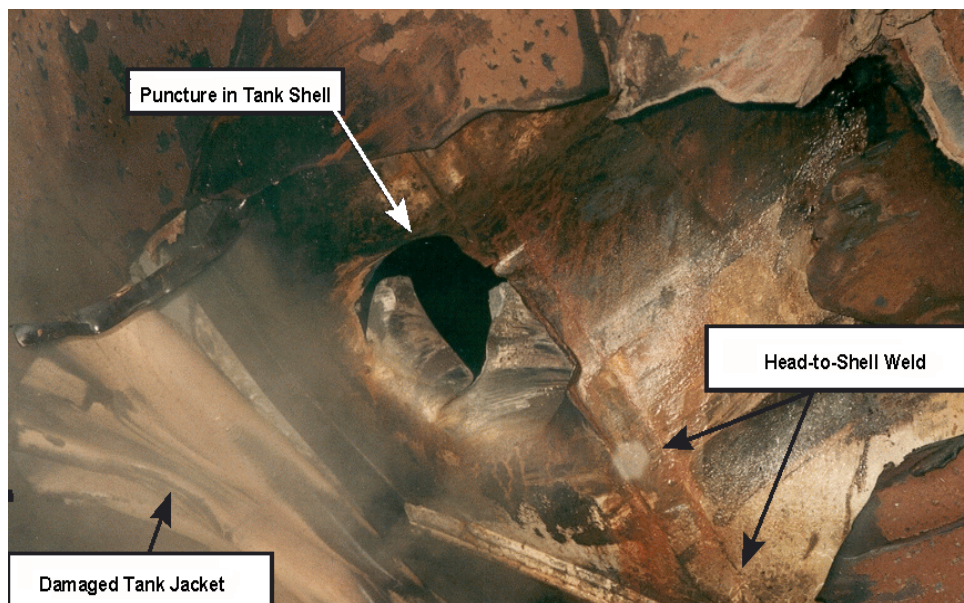
Of the three anhydrous ammonia tank cars, two were re-railed without incident (PROX 37789 and PROX 89119). Car PROX 89119 was slightly damaged by the fire at one end; however, no loss of product occurred. The tank shell of car PROX 81179 was breached. The breach was approximately 15 cm by 10 cm (6 inches by 4 inches) in diameter (see Figure 7). There were corresponding marks on the corner of a box car (CN 558474) that was located immediately in front of it. (The puncture in the ammonia car showed a direct match with the frame of the box car.) The head shield was crushed and displaced longitudinally, allowing the corner of the frame of the box car access to the corner of the tank.
