AVIATION OCCURRENCE REPORT

IN-FLIGHT LOSS OF CONTROL

**SUPERMARINE AIRCRAFT INC.
PZL M18A DROMADER
LITTLE MUSKRAT LAKE, ONTARIO
11 AUGUST 1994**

REPORT NUMBER A94C0160

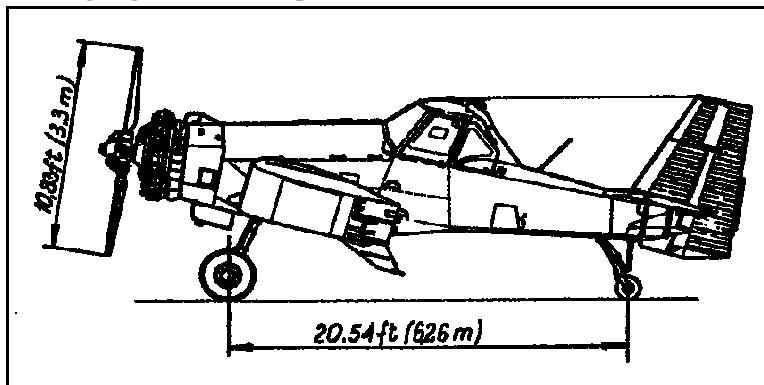
Figure 1 - PZL-M18A

hopper is located in front of the cockpit. The aircraft can be configured for aerial application of liquid or dry chemicals, or for forest fire fighting. The M18A Dromader differs from the M18 in that a rearward-facing mechanic's seat is added behind the pilot's seat and the aircraft battery is relocated to the forward part of the fuselage. Canadian regulations prohibit the carriage of personnel in the mechanic's seat.
