RAILWAY INVESTIGATION REPORT
R04E0027

MAIN-TRACK DERAILMENT

CANADIAN PACIFIC RAILWAY
FREIGHT TRAIN 575-03
MILE 86.9, RED DEER SUBDIVISION
RED DEER, ALBERTA
04 MARCH 2004

Report Number R04E0027

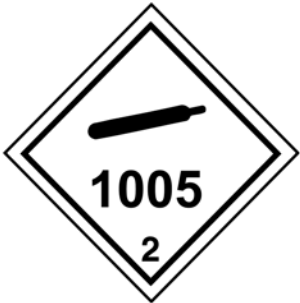
Figure 1: Examples of labelling for the transportation of dangerous goods

<p>Label and Placard</p> <p>Black or White: Symbol, number and line 5 mm inside the edge for a label and 12.5 mm inside the edge for a placard</p> <p>Green: Background</p> <p>The symbol is a gas cylinder.</p>	<p>Label and Placard</p> <p>Black: Symbol, number and line 5 mm inside the edge for a label and 12.5 mm inside the edge for a placard</p> <p>White: Background</p> <p>The symbol is a skull and crossbones.</p>
<p>Class 2.3, Toxic Gases</p>

<p>Optional Label and Placard for UN1005, Anhydrous Ammonia</p> <p>White background</p> <p>The symbol is a gas cylinder.</p>

Planned revisions to the *Transportation of Dangerous Goods Regulations* contain the following items, with examples shown in Figure 1:
