**RAILWAY INVESTIGATION REPORT  
R11Q0056**

**RUNAWAY TRAIN**

**QUEBEC NORTH SHORE AND LABRADOR RAILWAY  
FREIGHT TRAIN LIM-55  
MILE 67.20, WACOUNA SUBDIVISION  
DORÉE, QUEBEC  
11 DECEMBER 2011**

Report Number R11Q0056

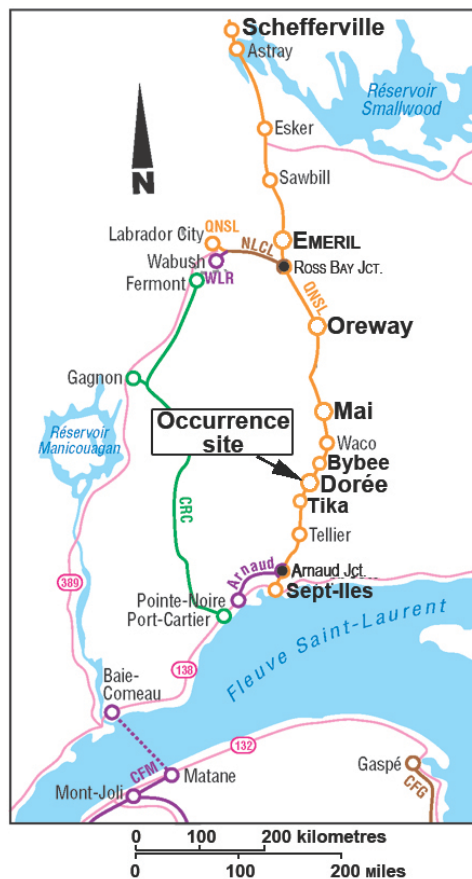
Figure 1. Occurrence site

On 11 December 2011, freight train LIM-55 (the train) loaded with iron ore left Emeril Junction, Newfoundland and Labrador, southward towards Sept-Îles, Quebec, on Quebec North Shore and Labrador Railway (QNS&L) Wacouana Subdivision (Figure 1). It consisted of 2 QNS&L locomotives and 112 Labrador Iron Mines (LIM) gondola cars. It weighed 10 070 tons and measured 6080 feet.

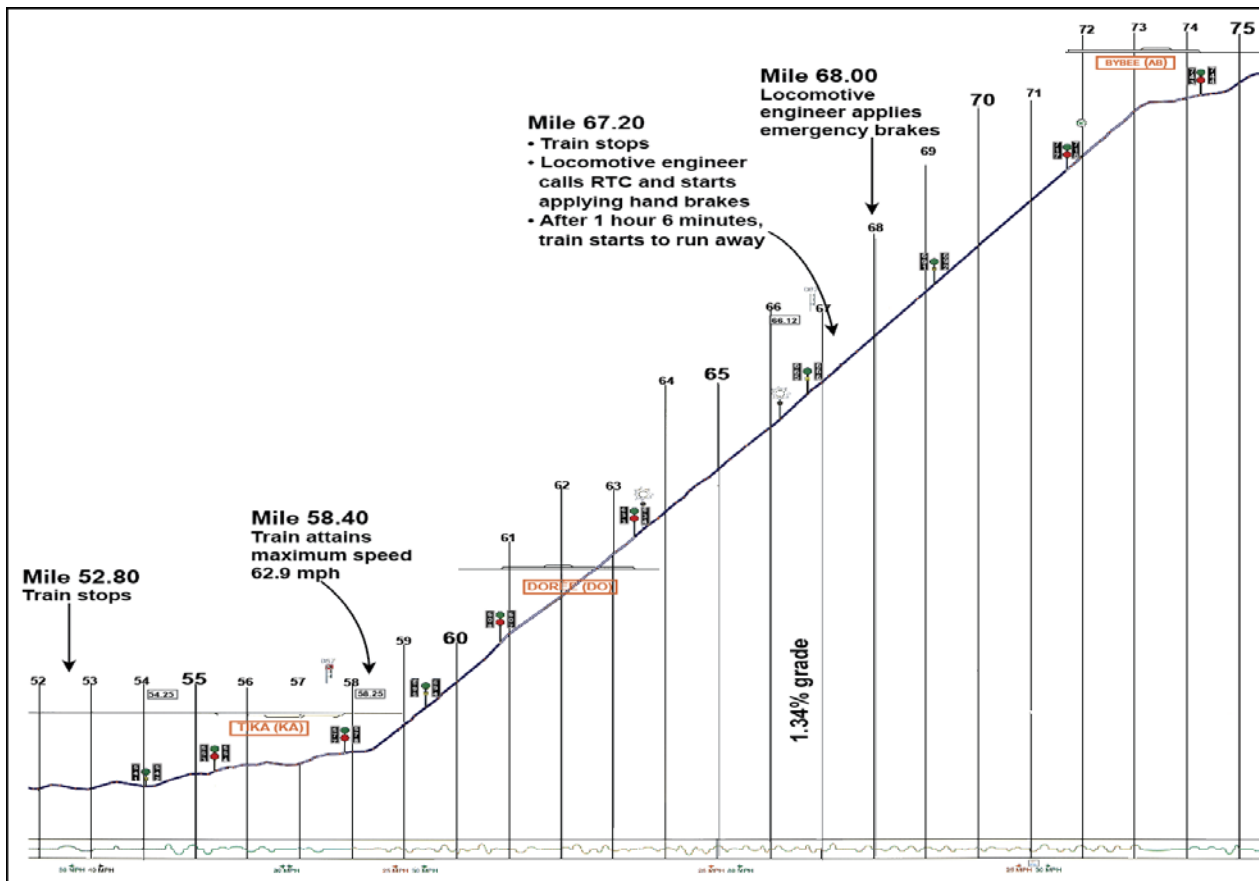
Figure 2. Grades in the occurrence area

Approaching the long grade between Bybee, Mile 73.00, and Tika, Mile 56.60, the locomotive engineer applied the brakes by reducing the brake pipe pressure by 10 psi to test their effectiveness. He then released the brakes when the speed started to decrease and re-applied them once the train reached a speed of 13 mph, and began the descent. When the train reached a speed of 25 mph, the maximum allowable speed in that area, the locomotive engineer gradually decreased the brake-pipe pressure to control train speed. However, the speed continued to increase and, when the train reached a speed of 38 mph, the locomotive engineer applied the emergency brakes. The train came to a stop at Mile 67.20.

The locomotive engineer contacted the RTC to advise of the situation and was instructed to apply hand brakes to secure the train and to wait for assistance. Just over an hour later, as the locomotive engineer was returning to the locomotives, he noticed that the train was starting to move. He boarded the lead locomotive and fully applied the dynamic brakes. However, the dynamic brakes were unable to control the movement and the train continued to accelerate, reaching a maximum speed of about 63 mph. The train finally came to a stop at the bottom of the slope, Mile 52.80, without derailing (Figure 2).
